**STRATFORD ARMY ENGINE PLANT
ASBESTOS UPDATE SURVEY**

18 March 2013

Re: Asbestos Resurvey Report, Stratford Army Engine Plant, 550 Main Street, Stratford, CT

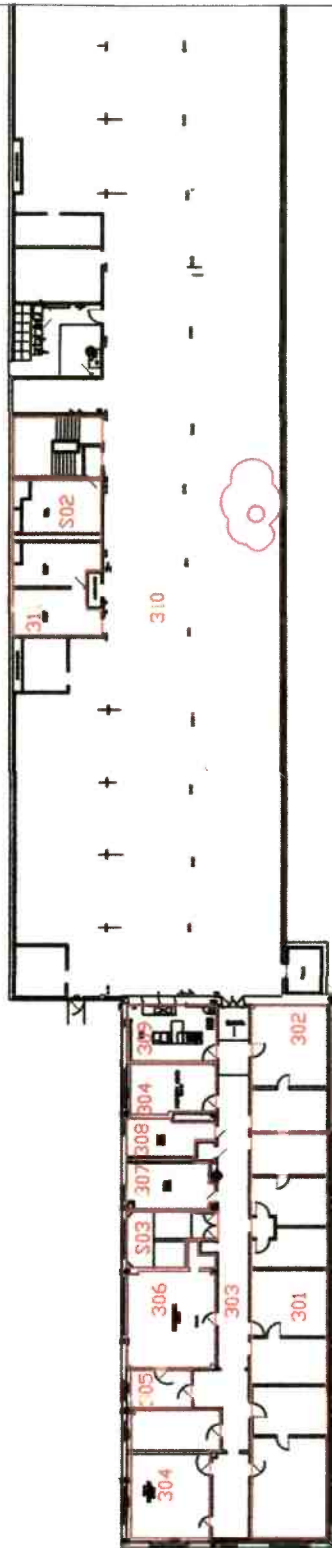
5 ASBESTOS SURVEY FEBRUARY 2013
BUILDING 1 FLOOR 3 - AREA A
STRATFORD ARMY ENGINE PLANT
STRATFORD, CT

ATTIC SPACE ABOVE THIRD FLOOR
SAMPLE 250-01 COLLECTED
