Re: Causeway 2012 Annual Inspection Report, Stratford Army Engine Plant, 550 Main Street, Stratford, CT

**VISUAL INSPECTION CHECKLIST, MAINTENANCE AND INSPECTION PLAN
CAUSEWAY COVER SYSTEM, STRATFORD ARMY ENGINE PLANT, STRATFORD, CONNECTICUT**

PHOTOGRAPH DOCUMENTATION
12 November 2012 CAUSEWAY COVER SYSTEM INSPECTION
STRATFORD ARMY ENGINE PLANT, STRATFORD, CONNECTICUT

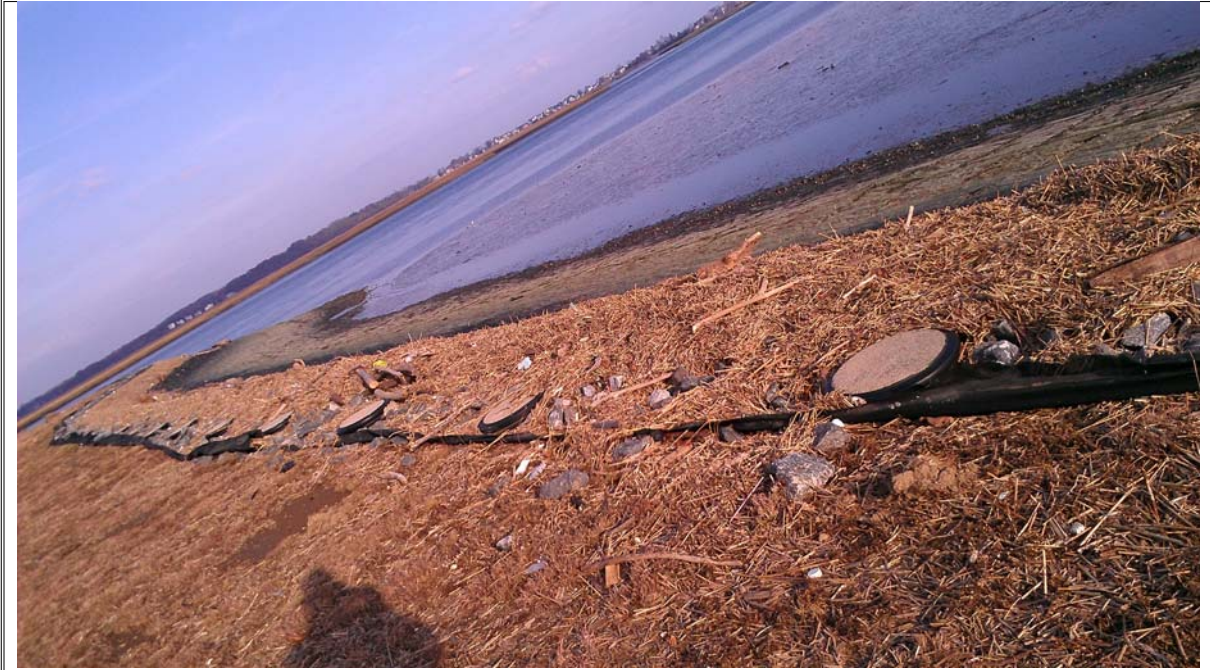
Photograph 7: Transition between upper and lower cover system, geotextile exposed adjacent to fence post base

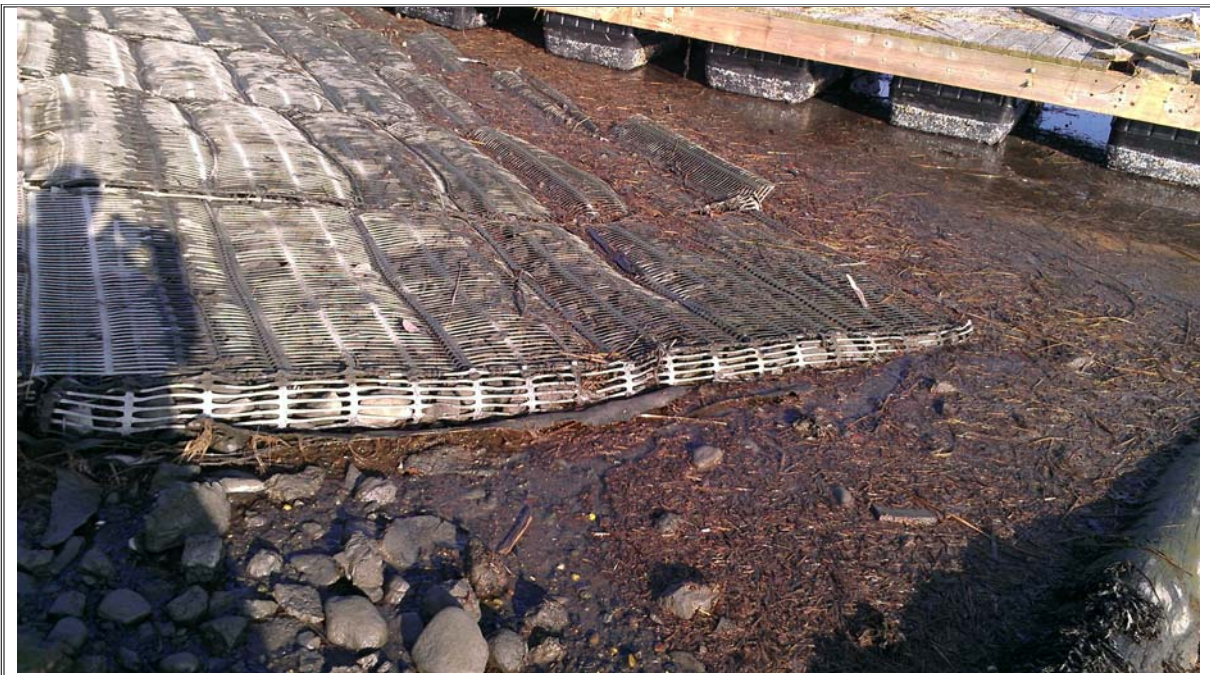
Photograph 8: Edge of marine mat at base of slope

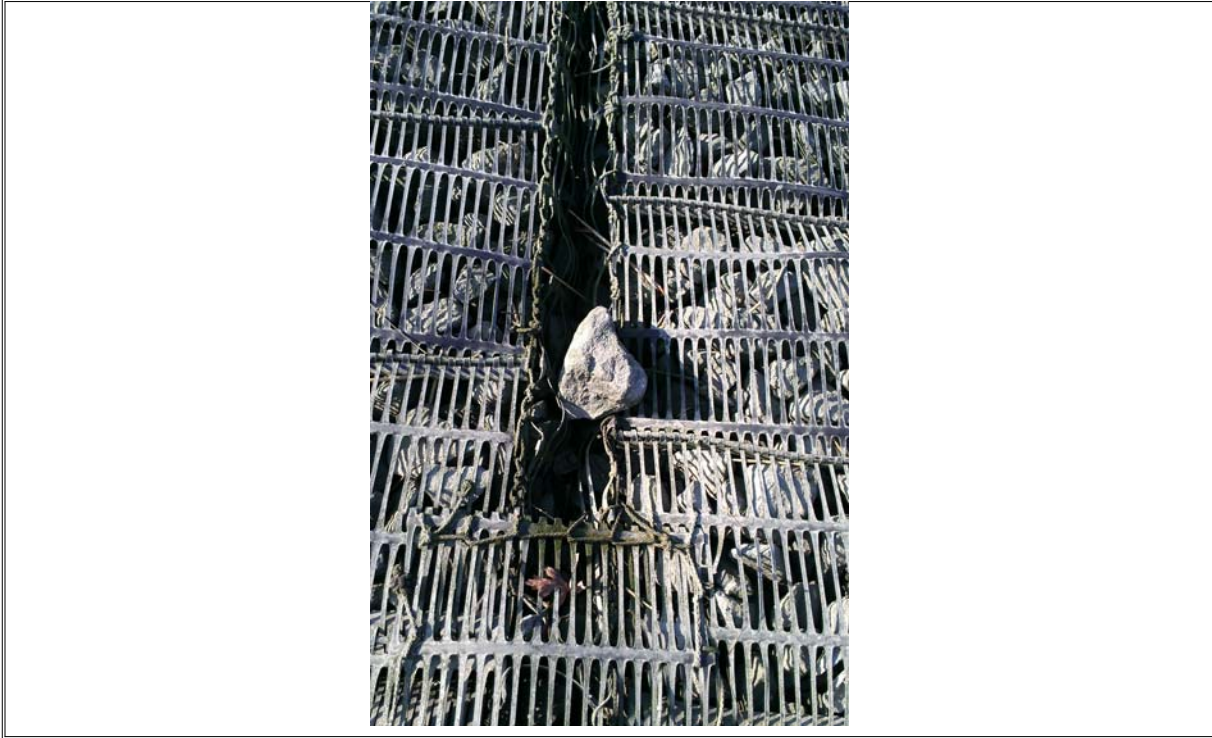
Photograph 9: Minor separation of marine mat units

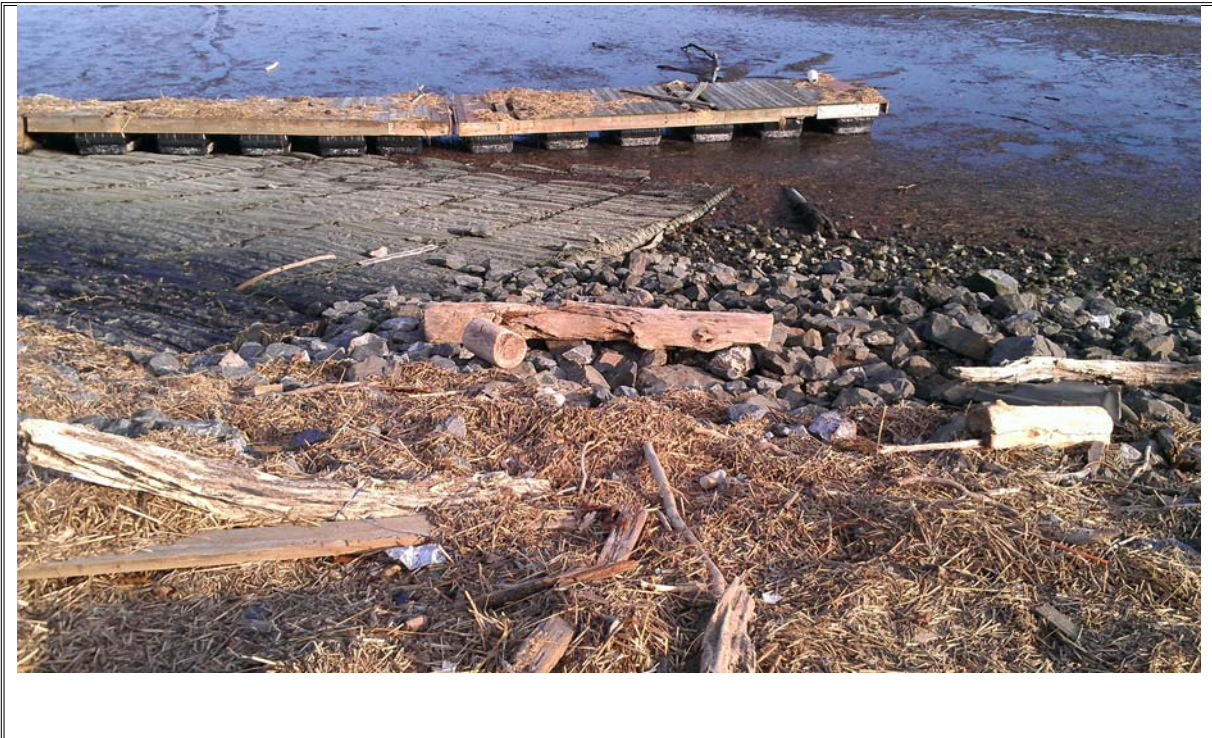
Photograph 10: View of southwest slope of causeway. Driftwood stump and floating dock structure deposited during passage of Hurricane Sandy on 29 October 2012

Marine mat/geotextile: Storm transported debris should continue to be carefully removed from the marine mat in a manner that will not cause damage to the mat enclosures when it washes up on the causeway. The minor tearing noted at various locations should be repaired, as should the frayed/separated braided rope sections. The small sections of exposed geotextile should be trimmed away to prevent further exposure of this component. The exposed geotextile at the vegetative cover/sideslope interface was stable and no recommendations other than avoidance of ensnaring the geotextile during mowing operations appear to be warranted.

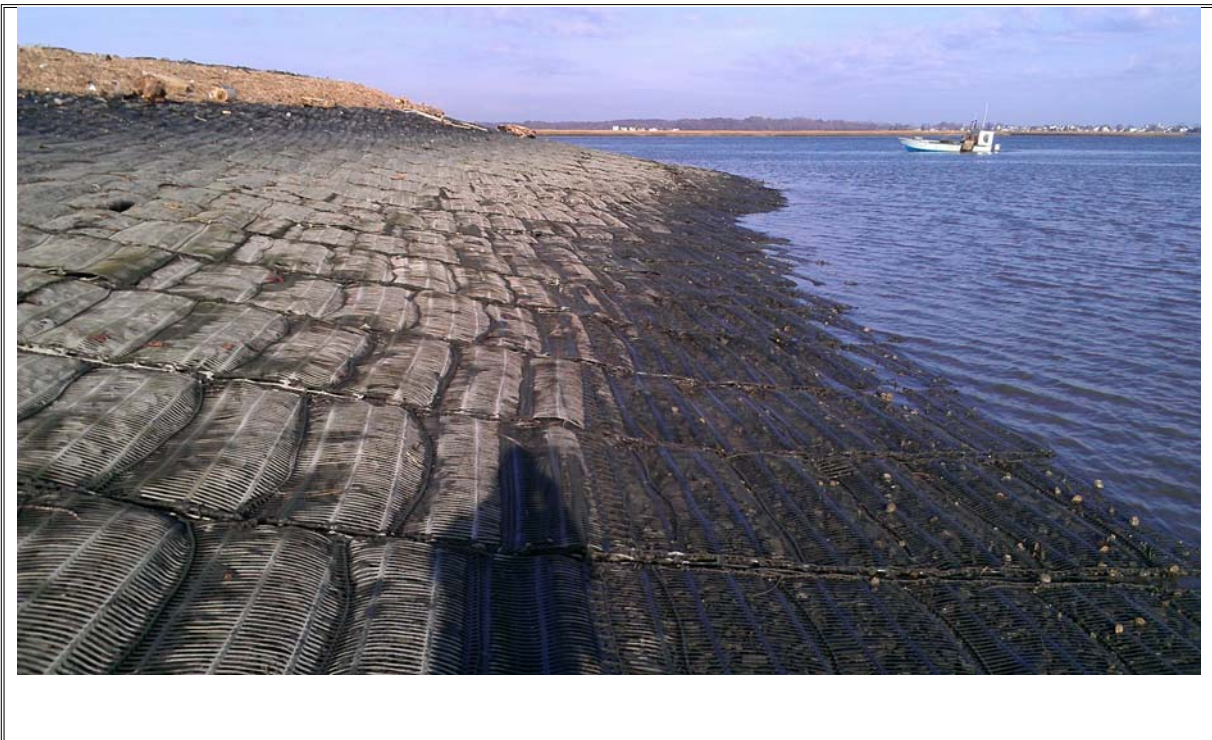
Photograph 12: East face of causeway at north end showing storm debris and some differential mat settling

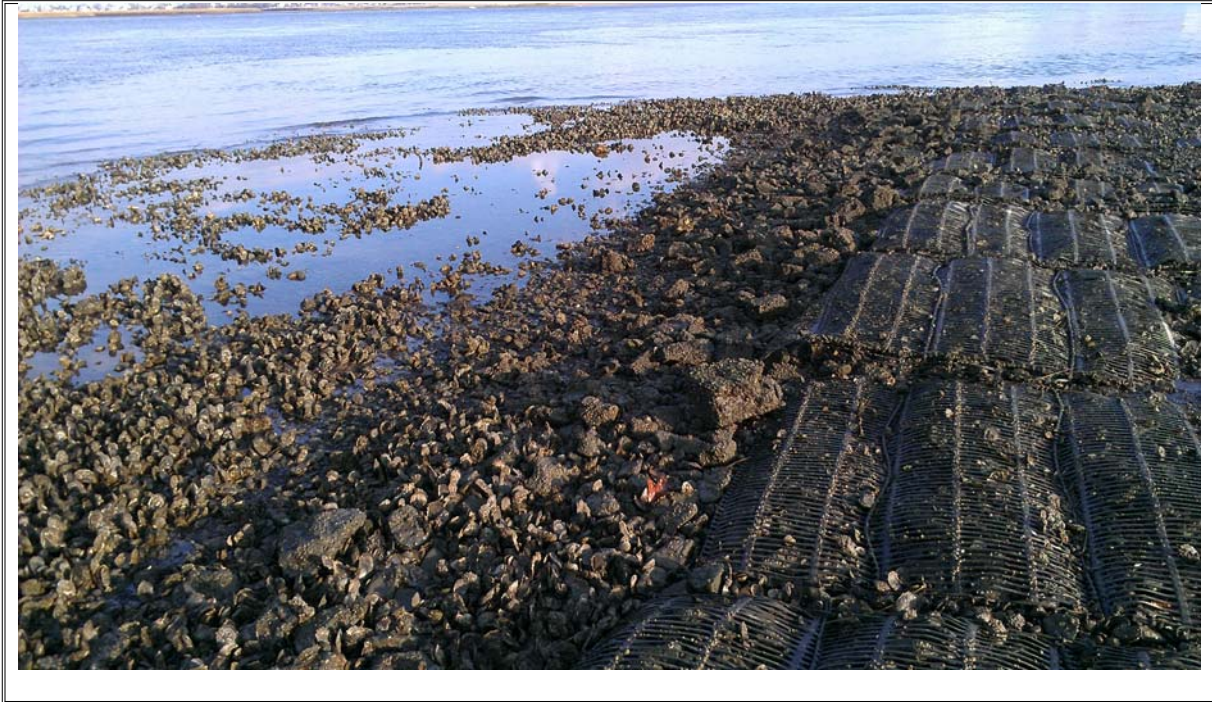
Marine organism growth on/within mats – An increase in shellfish attachment and barnacles on the accumulated cobble sized stones along the normally submerged edges of the toe of the slope at the northeast point. No significant vegetative growth was present on the mat slopes.

Photograph 13: Eastern tip of causeway showing cobble and shellfish accretion on marine mat

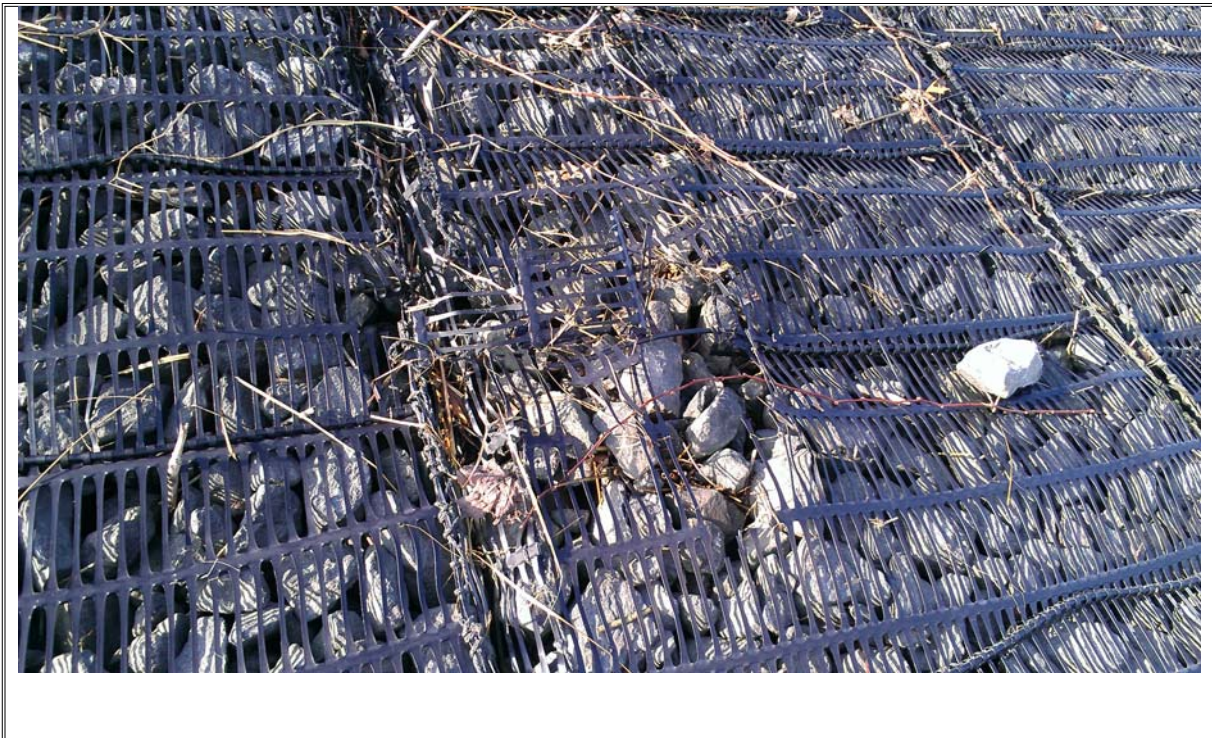
Photograph 14: Marine mat on east side of causeway showing surface tear

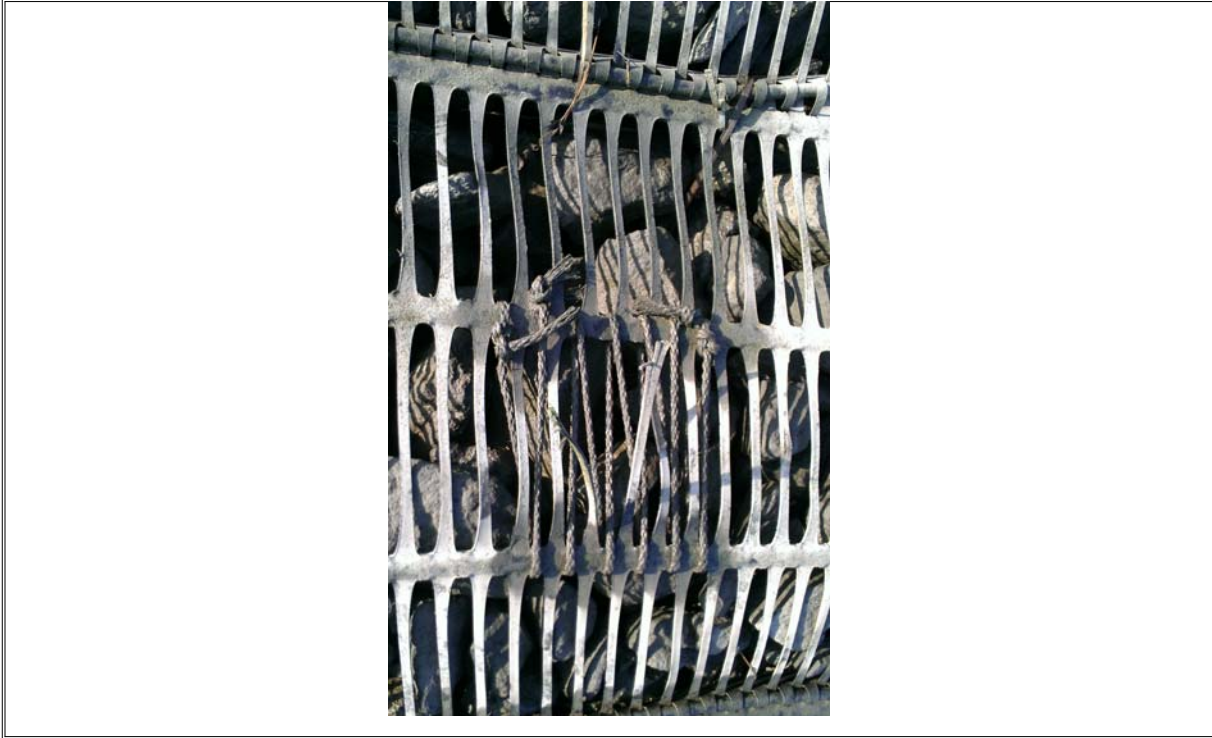
Photograph 15: Marine mat with repair to torn section

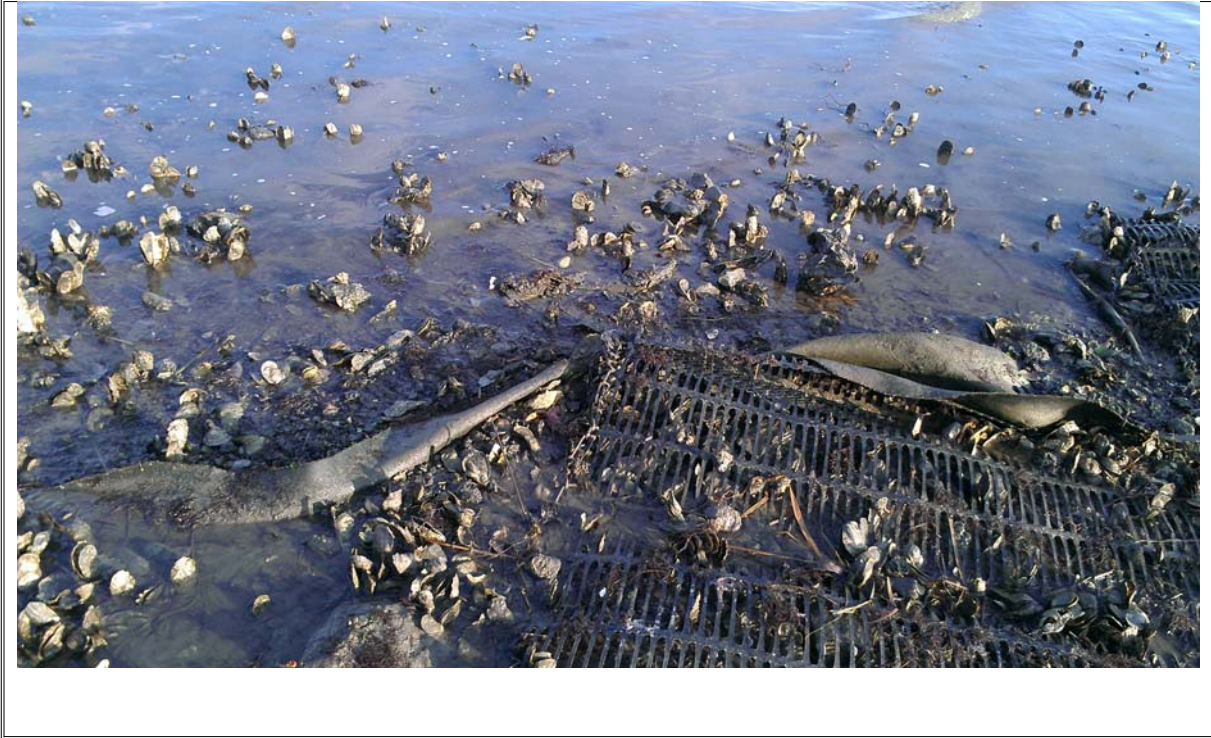
Underlying geotextile exposure/deterioration – Geotextile exposure was present at the northeastern tip of the causeway, the midpoint of the westerly side, and at the mat/riprap transition on the southwest side of the causeway. No significant undermining of the mat was present. It appeared that the exposed geotextile may have been due to minor scouring/undermining of the base edge of the mat. At the top of the mat edge/vegetative surface interface, the geotextile was exposed, but was folded over and appeared to be as installed rather than having been exposed due to erosion. It appeared to be in a stable configuration.

Photograph 17: Marine mat edge at northeast tip of causeway showing minor woven geotextile base exposure

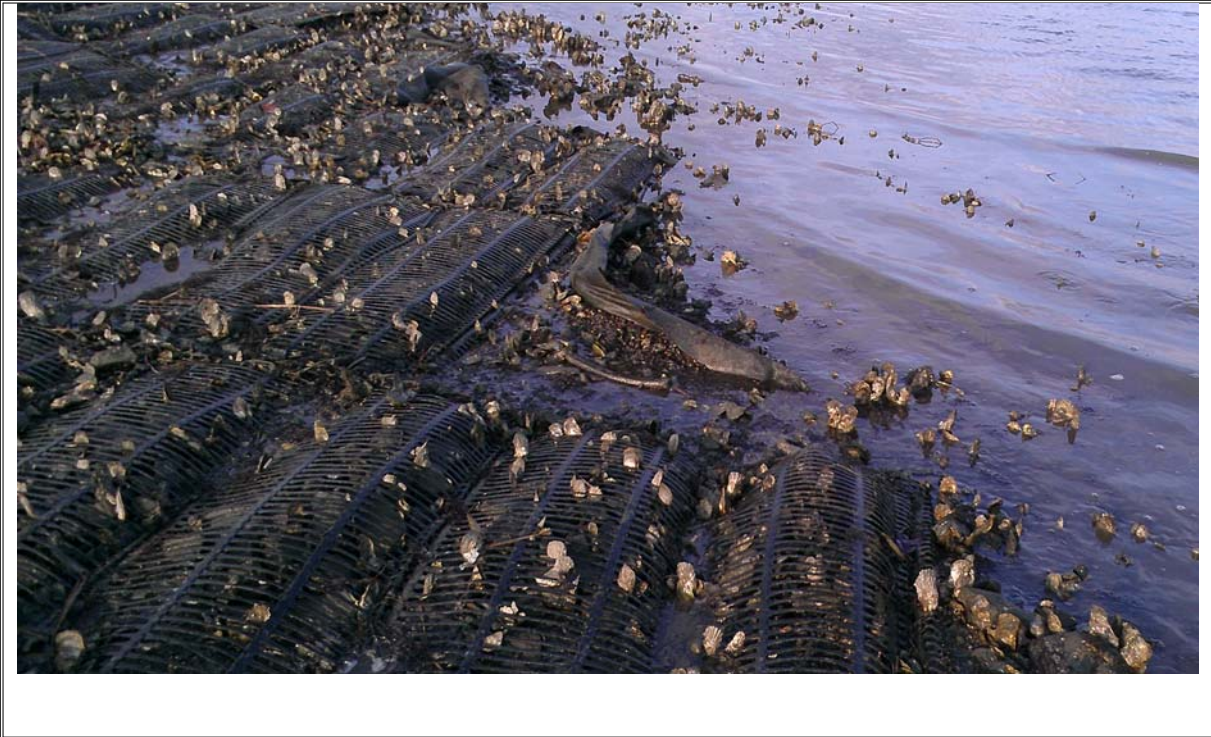
Photograph 18: Marine mat edge at northeast tip of causeway showing minor woven geotextile base exposure, second view

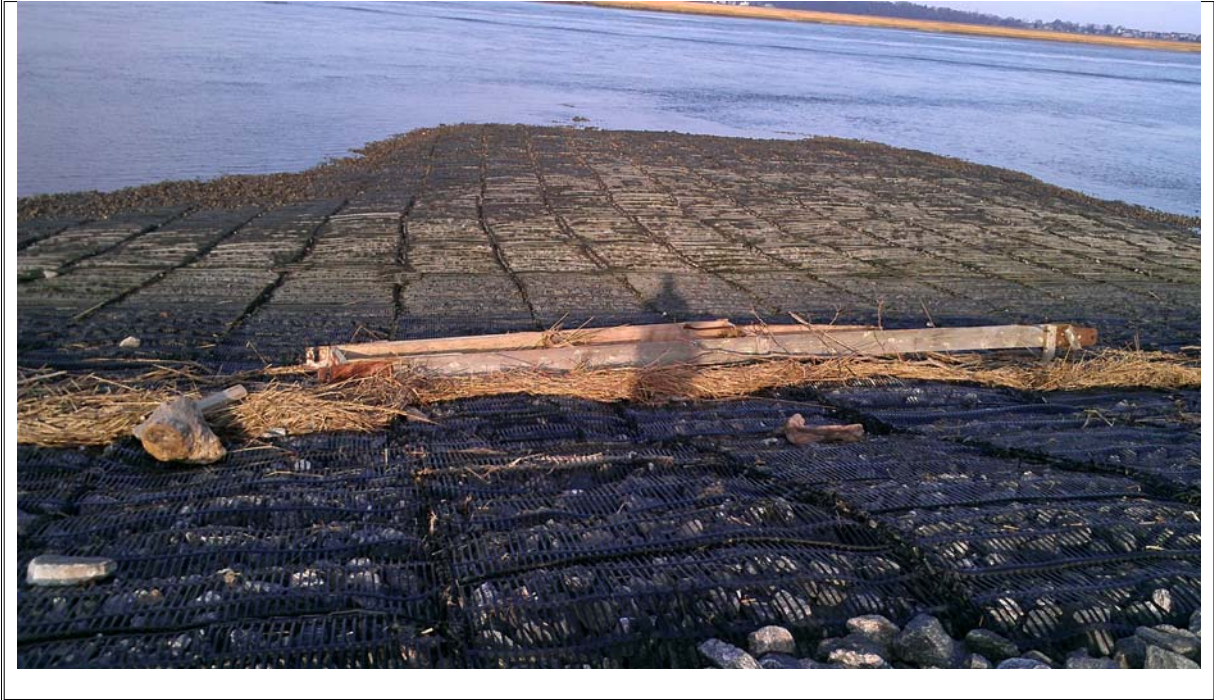
Photograph 19: Eastern tip of causeway showing general marine mat condition and storm debris

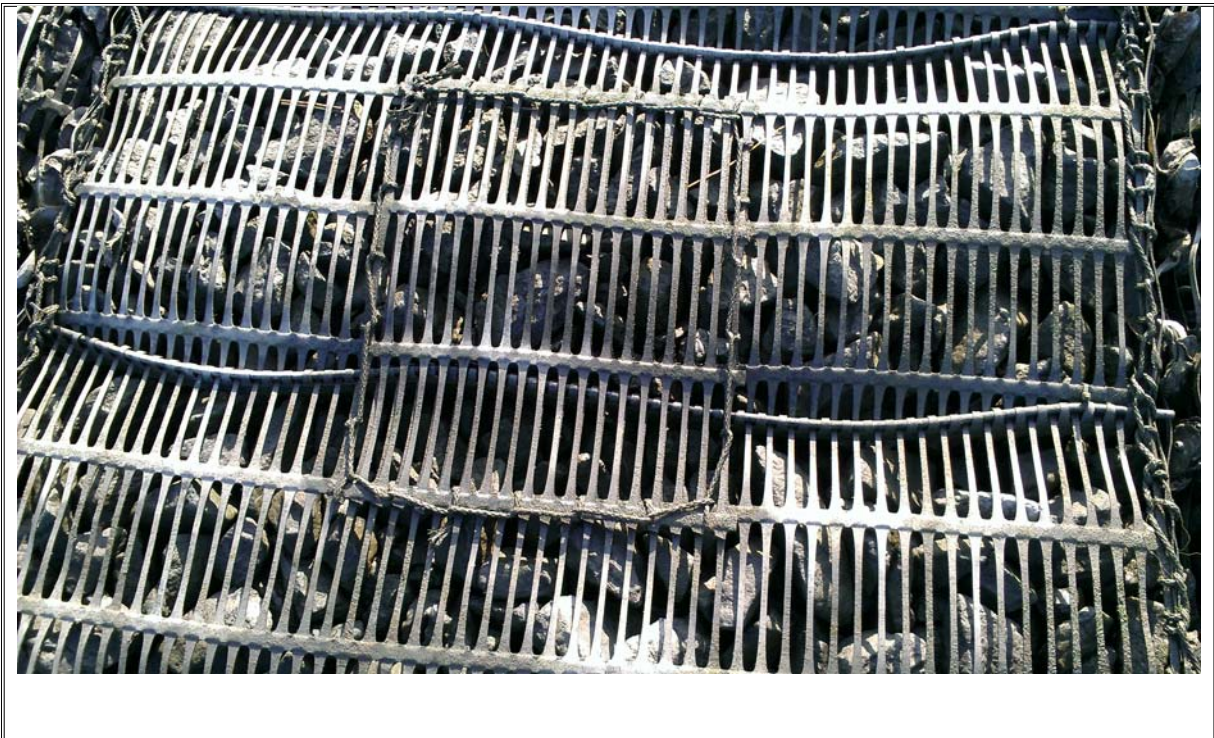
Material condition – cracking, crazing, tensile failure, stress discoloration – Materials appeared to be in good condition, with no significant cracking, crazing, or stress discoloration noted (see photo of typical mat condition). The only tensile failures noted were at a few mat edges, and a small area where a large driftwood tree trunk was lying on the mat surface.

Photograph 20: Marine mat at eastern tip of causeway showing typical condition

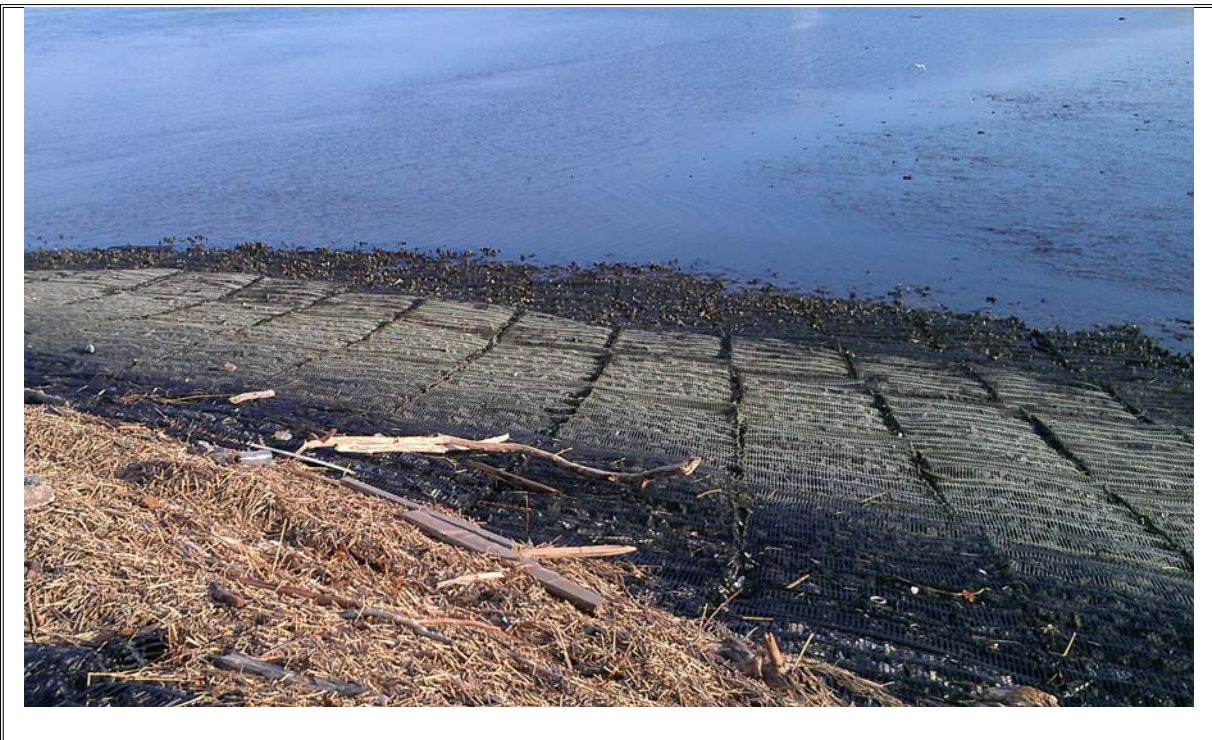
Photograph 22: Marine mat at eastern end of causeway showing minor differential settlement

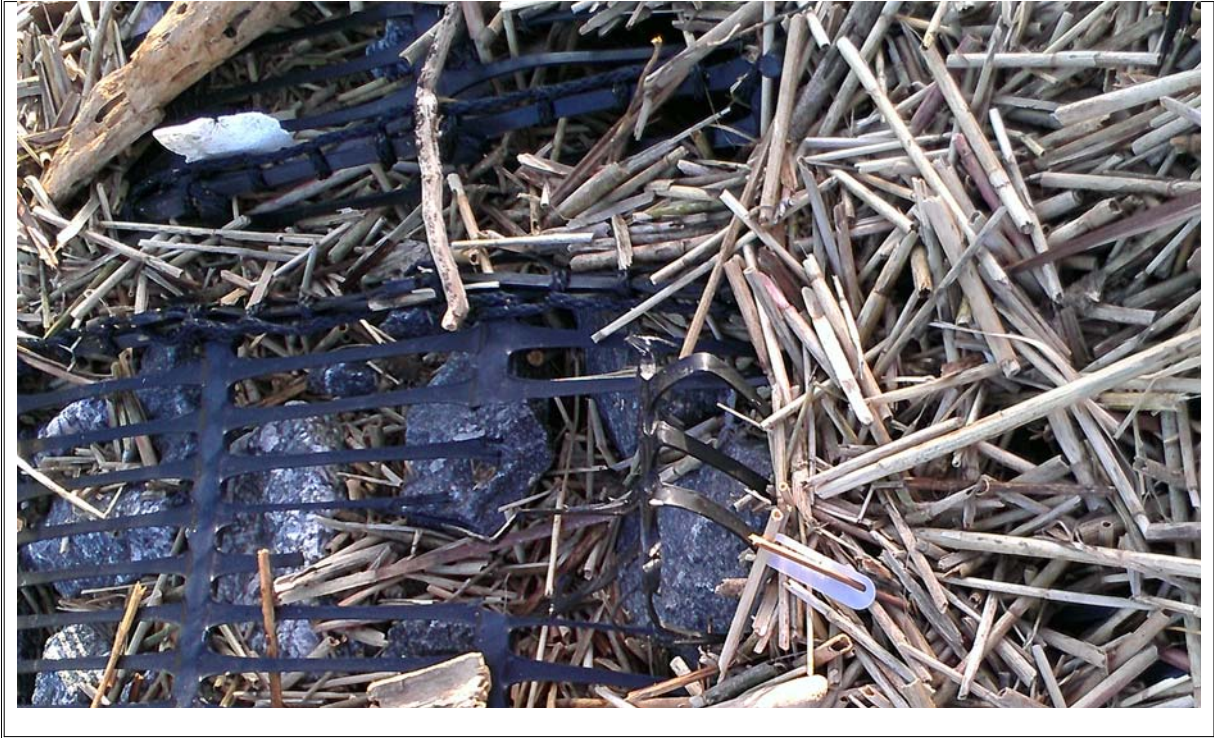
Photograph 23: Marine mat at eastern end of causeway showing minor tear

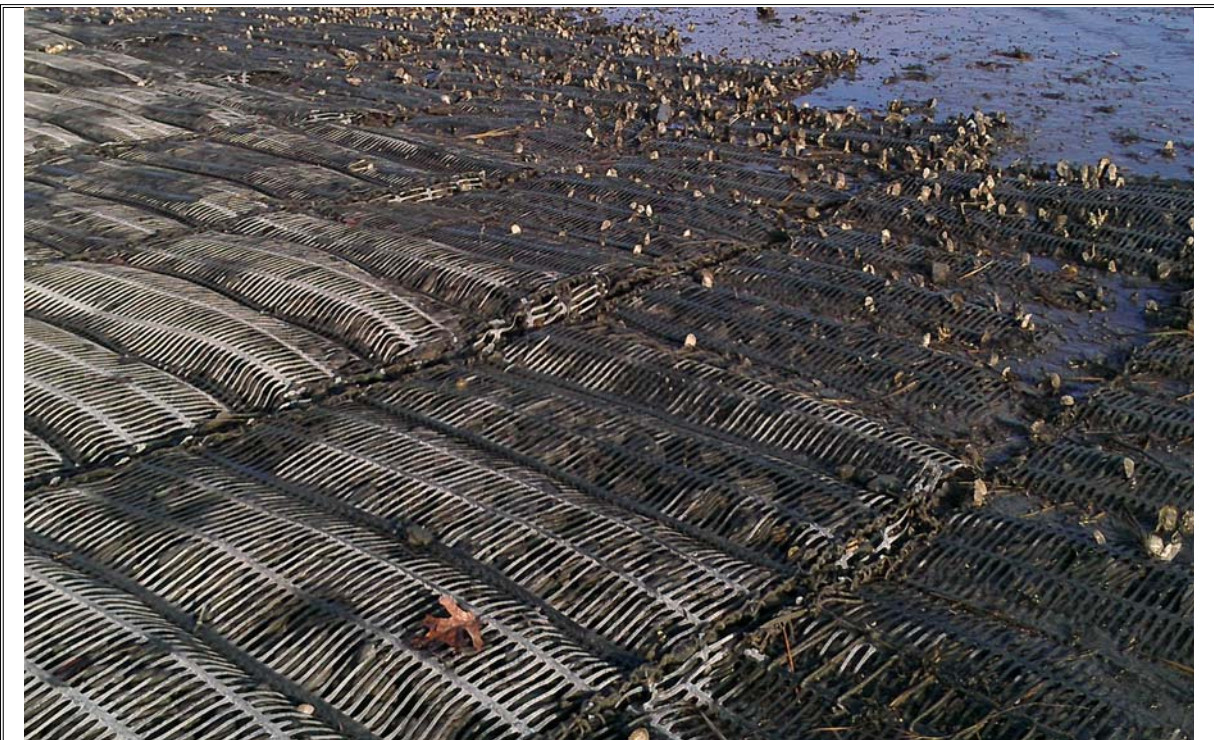
Photograph 24: Marine mat at eastern end of causeway showing minor differential settlement

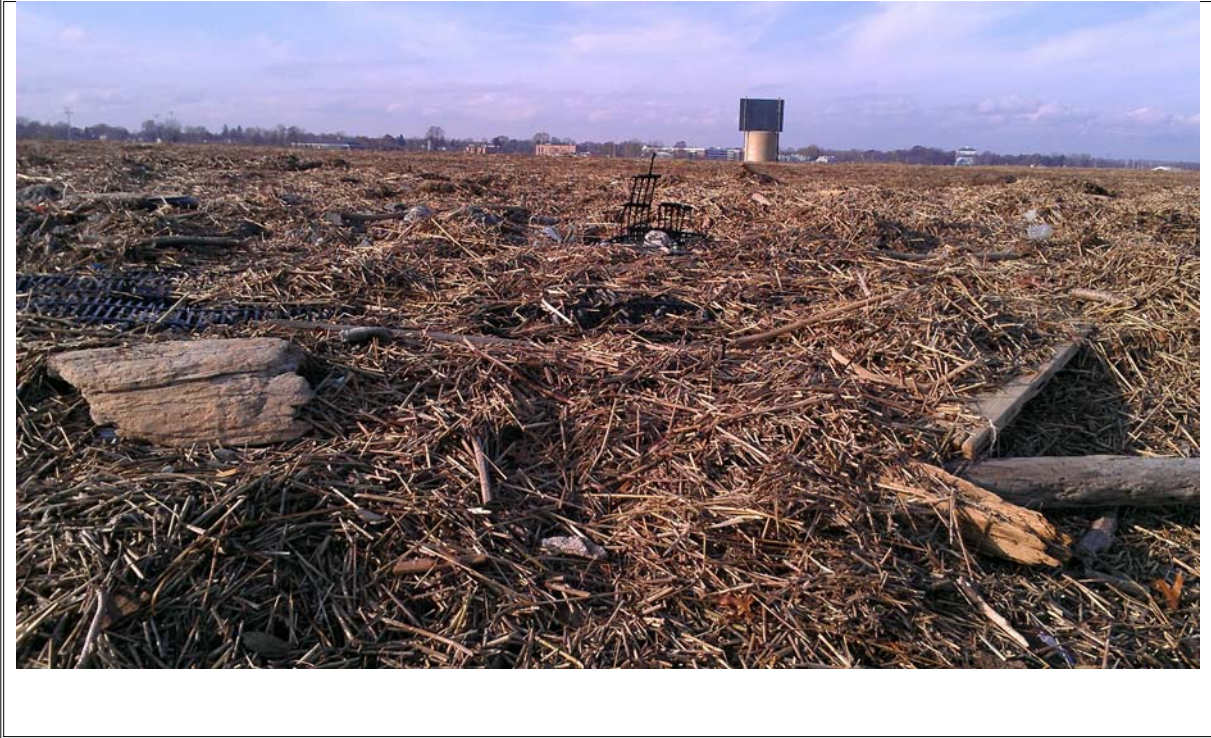
Condition of vegetative cover including bare spots, stress areas, and evaluation of mowing requirements – The vegetation on the causeway top was impacted from the storm event, with debris deposited across the entire surface. Most of the debris was vegetative in nature, consisting of dead reeds and branches. Portions of the grassed surface were disturbed by machinery used to remove the debris. The remainder was brown, most likely due to saltwater inundation. As is shown in the attached photographs, vegetation was sparse or lacking in a number of areas, and the predominant plants were weeds rather than turf grass. This is of concern, as if additional overtopping events occur, the lack of a dense root mat could allow damage to the soil surface.

Photograph 33: Top of eastern side of causeway showing storm debris and vegetation condition

Surface cover: Strip vegetation from vegetative cover surface, grade/rake surface to eliminate uneven areas adding topsoil as necessary, apply limestone and fertilizers as specified in the attached analysis, and reestablish appropriate turf vegetation. A mix of red fescue, perennial rye grass and Kentucky bluegrass is recommended. If turf is significantly impacted during dry weather conditions and/or if inundation with saltwater can reasonably be expected to recur, serious consideration should be given to installing an irrigation system. A healthy turf root system is essential to preventing disruption to the cover system from overtopping events as had happened in 2011 and 2012.

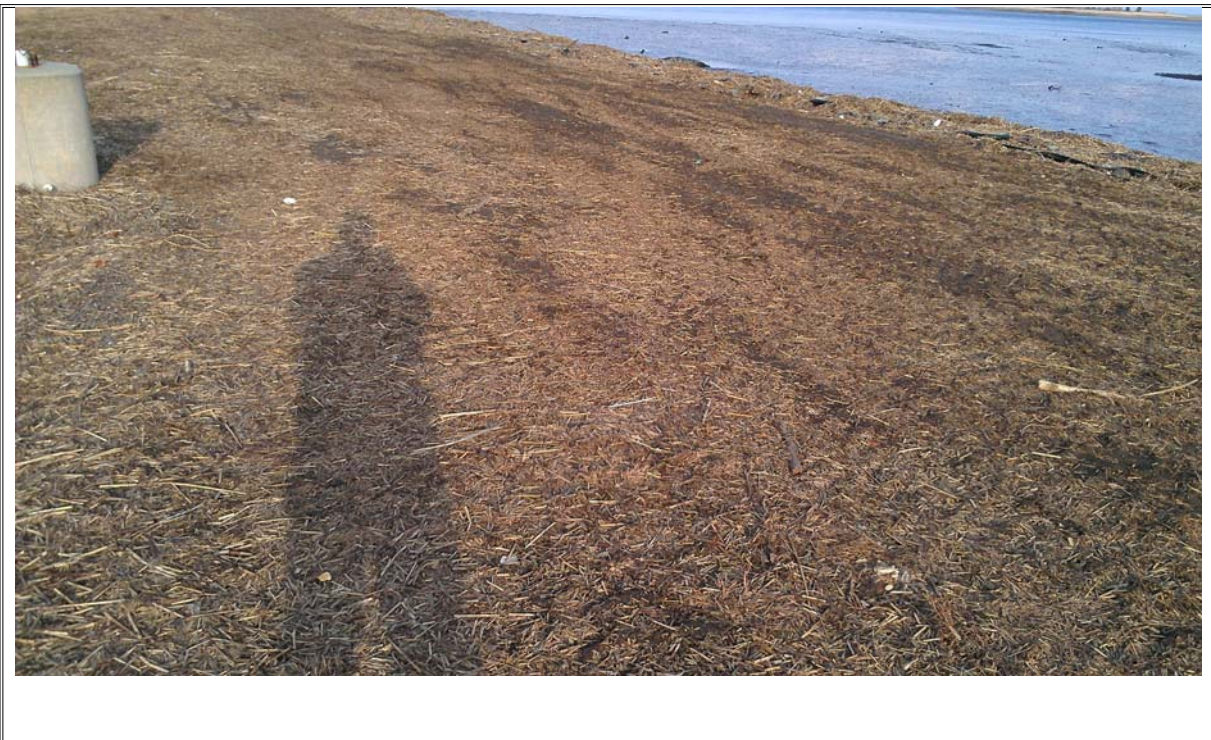
Photograph 34: Top of eastern side of causeway showing vegetation condition

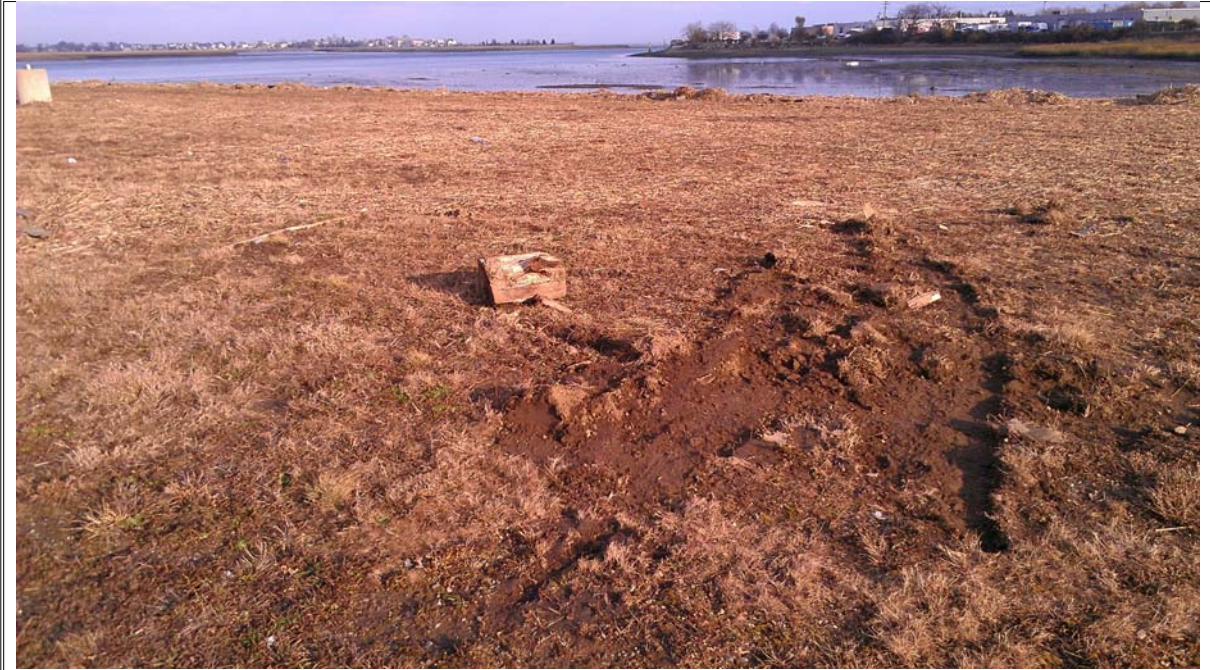
Photograph 35: Vegetative cover on causeway showing typical bare spots

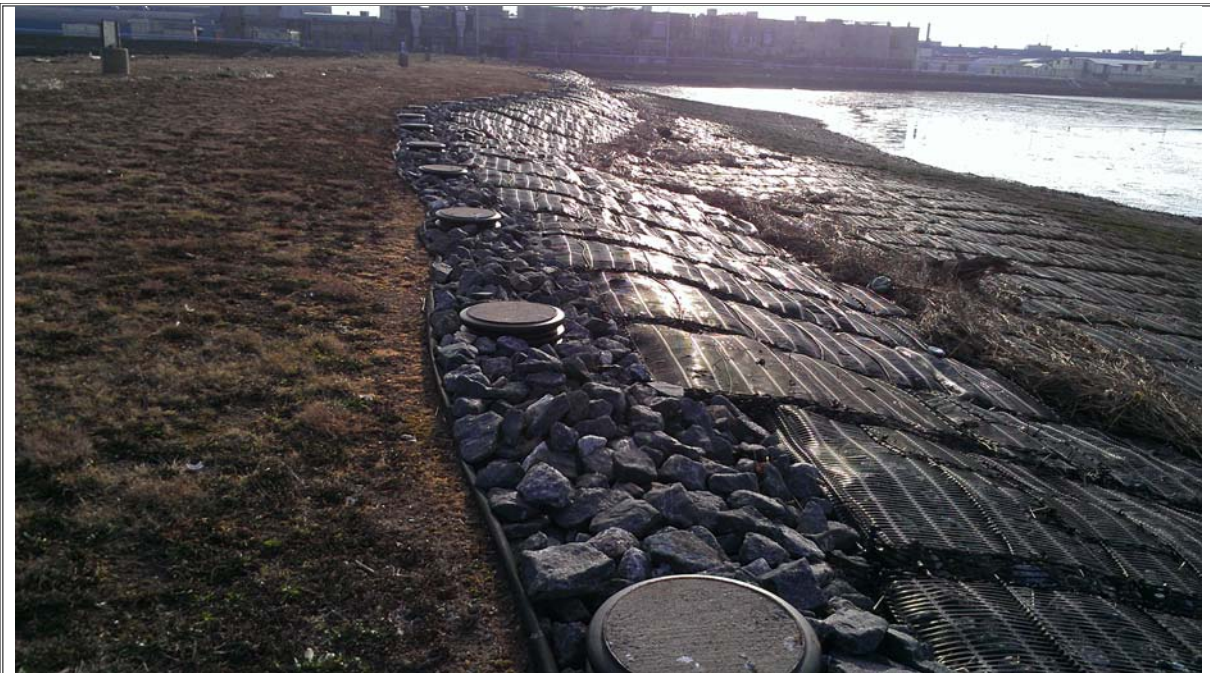
Photograph 36: West face of causeway showing storm debris

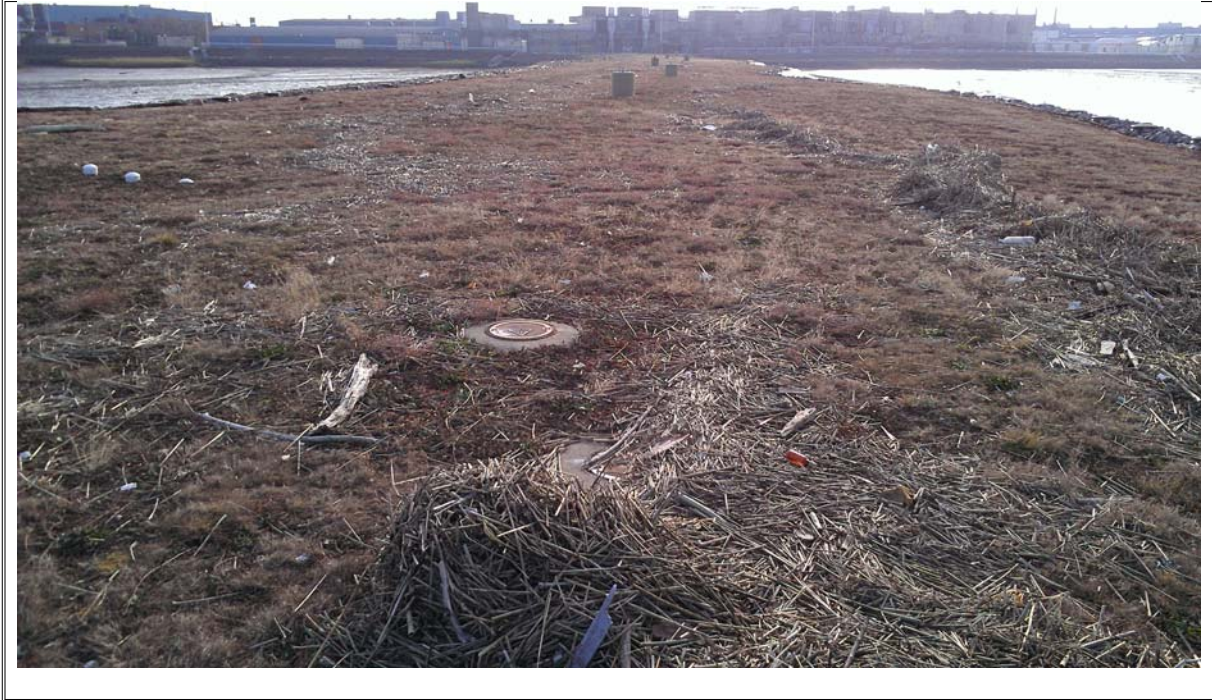
Condition of groundwater monitoring wells including labels, covers, and protective casings – Monitoring wells appeared to be in good condition, with no deterioration of protective casings, covers, or

concrete anchoring. A light layer of corrosion was present on some casing covers. No labels were noted on the well protective boxes.

Photograph 37: View of easterly monitoring wells

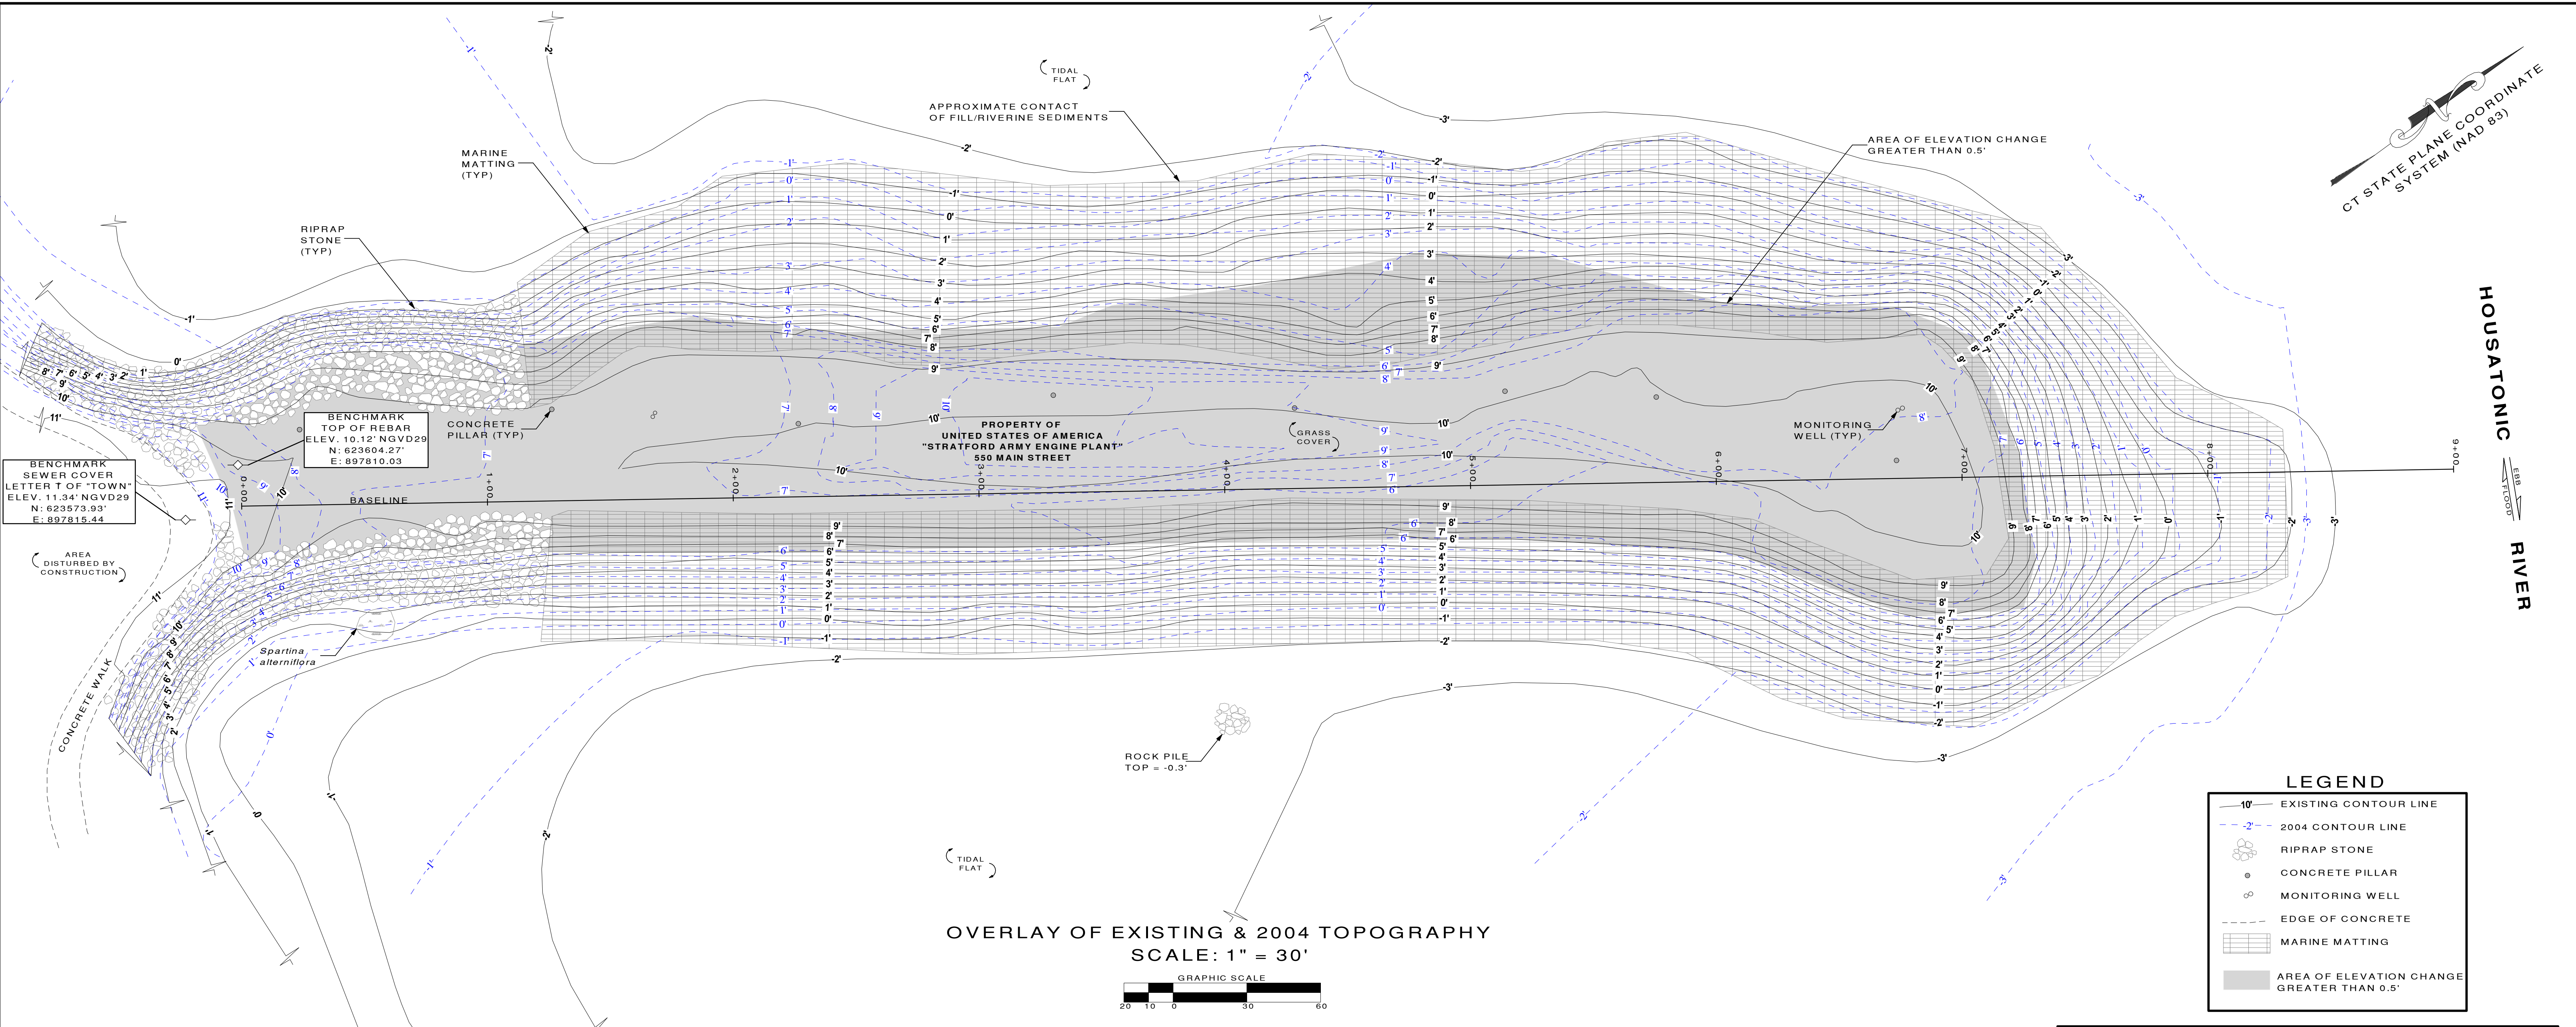
OVERLAY OF EXISTING & 2004 TOPOGRAPHY
SCALE: 1" = 30'

The overlay of the 2012 topographic survey on the 2004 survey did not indicate significant areas of settlement. Interestingly, the 2012 survey indicated the area currently occupied by the vegetated (grass) cover was generally slightly elevated as compared to the 2004 survey. There appear to be no areas of destabilization present at the causeway.
