FINAL
NON-TIME CRITICAL REMOVAL ACTION
CERTIFICATION REPORT
CAUSEWAY CONSTRUCTION

PHASES I AND II

STRATFORD ARMY ENGINE PLANT
STRATFORD, CONNECTICUT

DECEMBER 2003

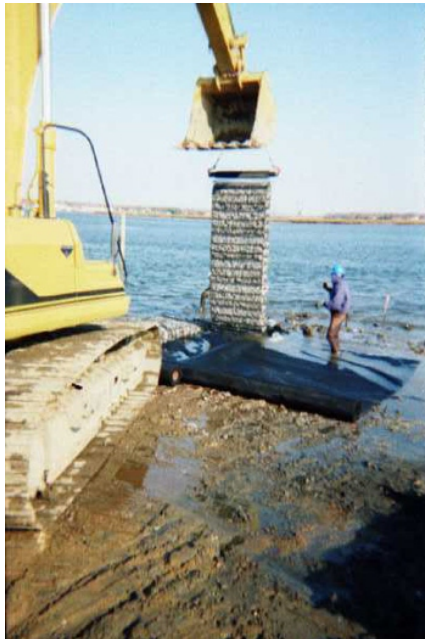
3. Marine mattress deployment over geogrid reinforced toe detail.

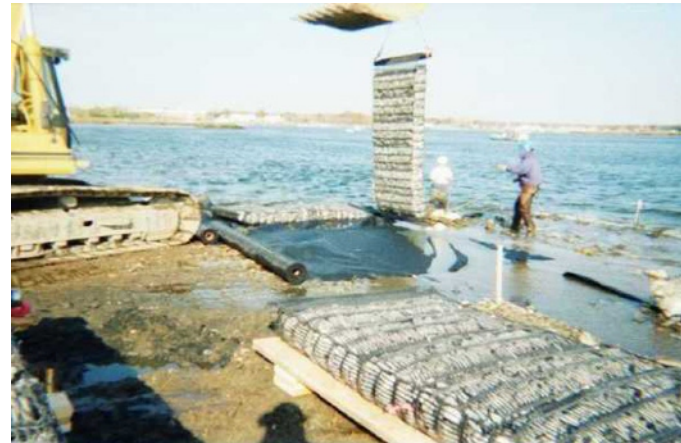
4. Marine mattress deployment at low tide (looking north towards Housatonic River channel).

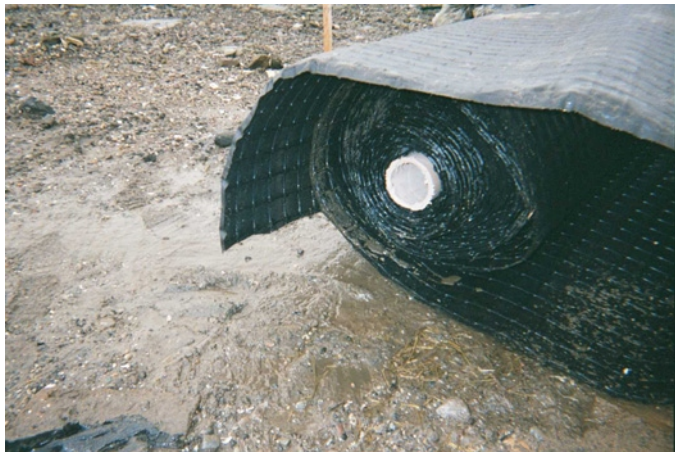
7. Reinforced geogrid utilized under riverine sediment/causeway fill interface details to provide support for marine mattresses.

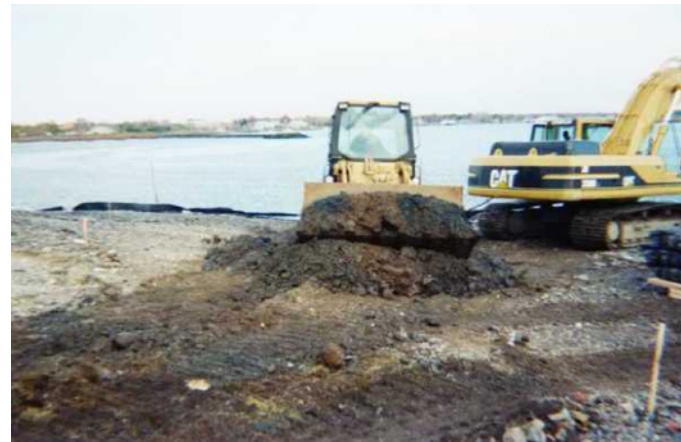
8. Relocating subgrade spoil excavation from lower cover system for scarification and drying.

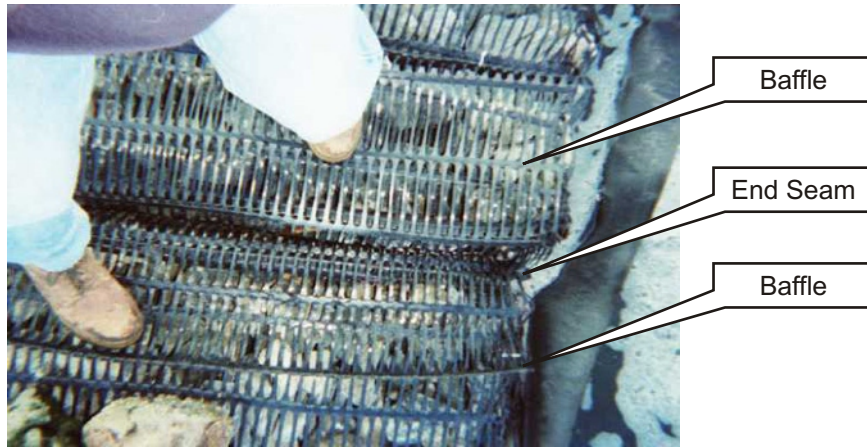
13. Deployed marine mattress end seam gap.

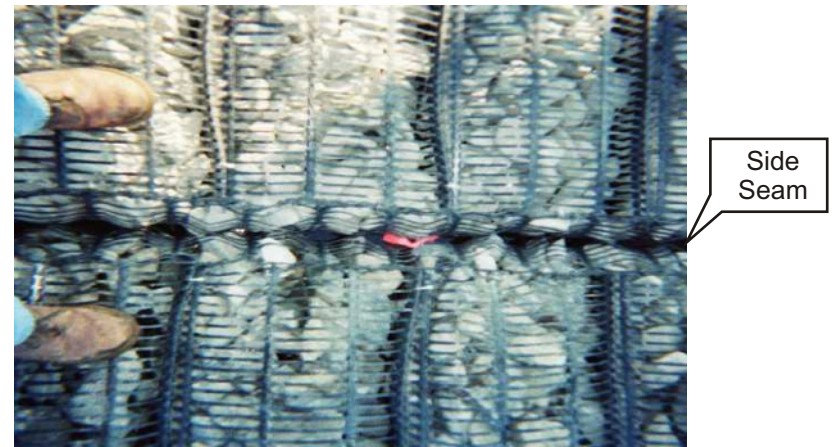
14. Deployed marine mattress side seam gap. Note individual baffle pillows within mattress units.

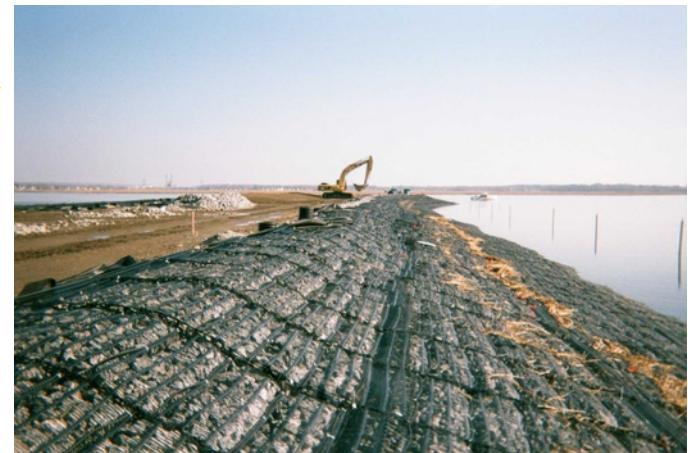
16. Completed area of marine mattress on east side of causeway. Note red flagging indicating QA inspection identified deficiencies.

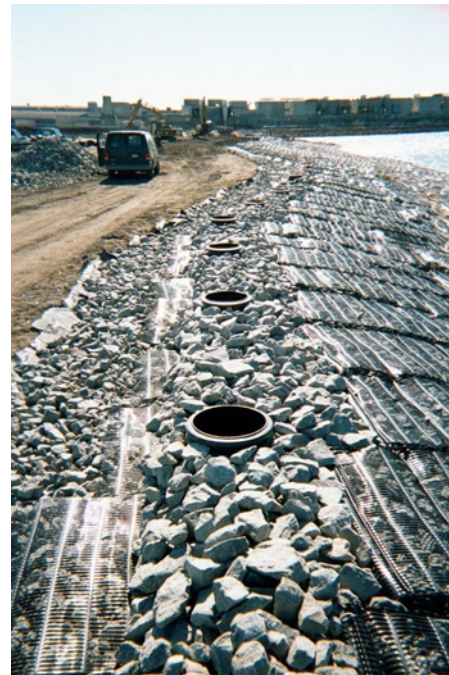
20. Completed rip rap transition with installed fence post bases as a component of Town of Stratford surface design. Note geogrid tab restraints under rip rap.

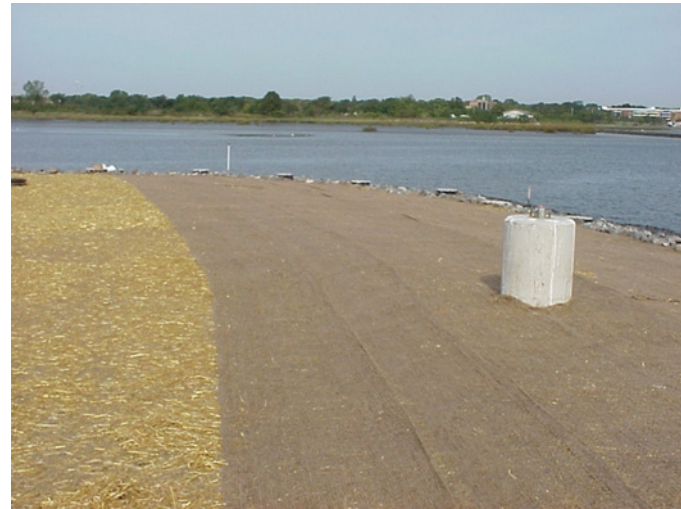
30. Looking north along Causeway with final grading, jute mat application and straw mulch, (photo courtesy of R. F. Weston).

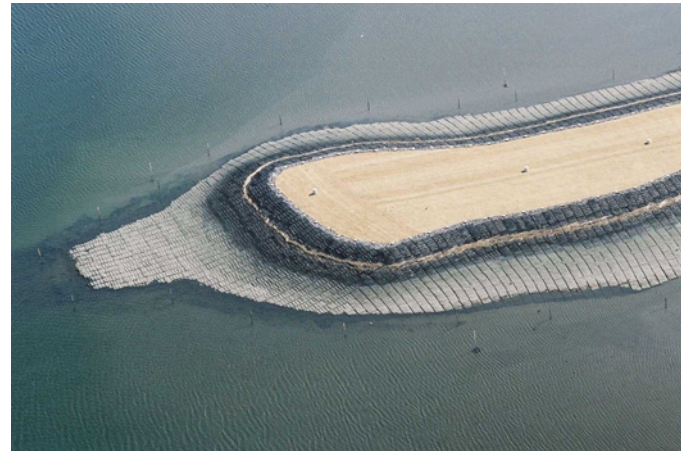
32. Aerial view of Causeway tip post bedding sand application. Note grayish color of marine mattresses indicating algae growth, (photo courtesy of R. F. Weston).
