**MAINTENANCE AND INSPECTION PLAN  
FOR CAUSEWAY COVER SYSTEM  
STRATFORD ARMY ENGINE PLANT  
STRATFORD, CONNECTICUT**

**U.S. ARMY CORPS OF ENGINEERS-NEW ENGLAND DISTRICT**

**Harding ESE, Inc., a MACTEC Company**

January 2004

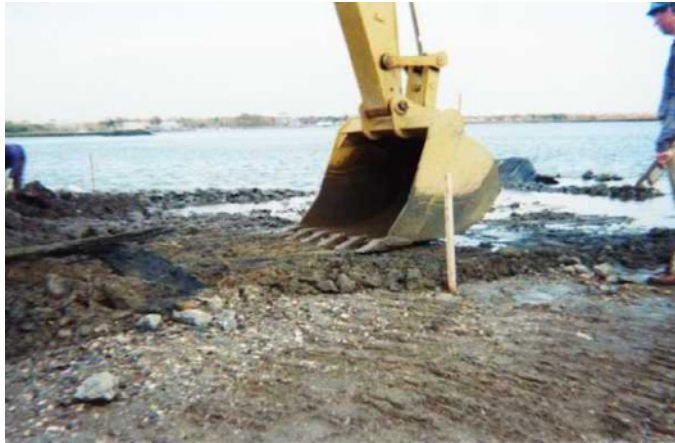
1. Subgrade soil, 1-foot cut to accommodate lower cover system marine mattresses placement.

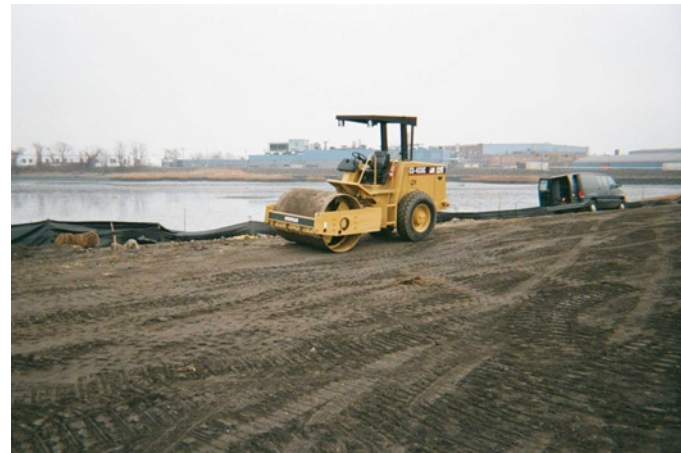
2. Compaction of acceptable subgrade fill in upper cover area (static load only).

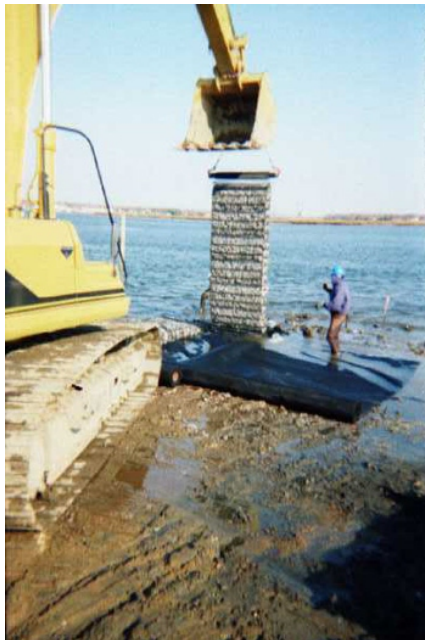
3. Marine mattress deployment over geogrid reinforced toe detail.

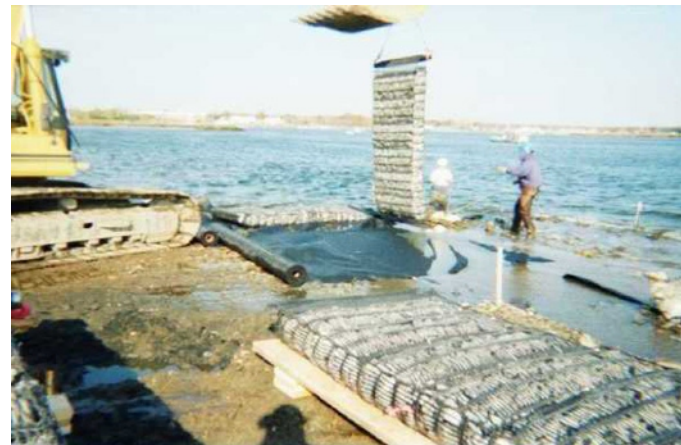
4. Marine mattress deployment at low tide (looking north towards Housatonic River channel).

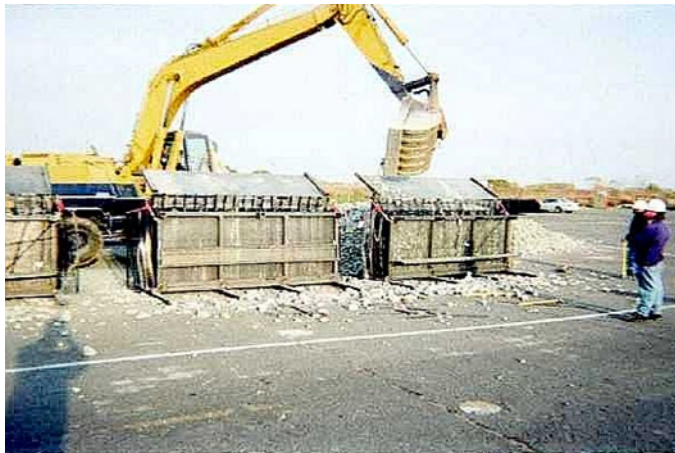
5. Filling factory fabricated marine mattresses with crushed D50 = 3-inch aggregate in South Parking Lot SAEP.

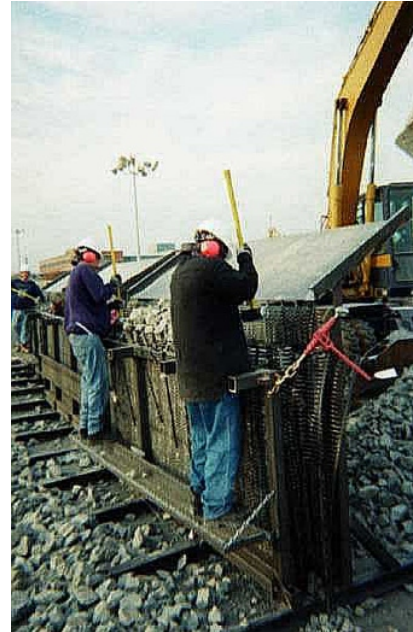
6. Detail of aggregate filling operations for marine mattress. Note tamping of stone into mattress baffles.

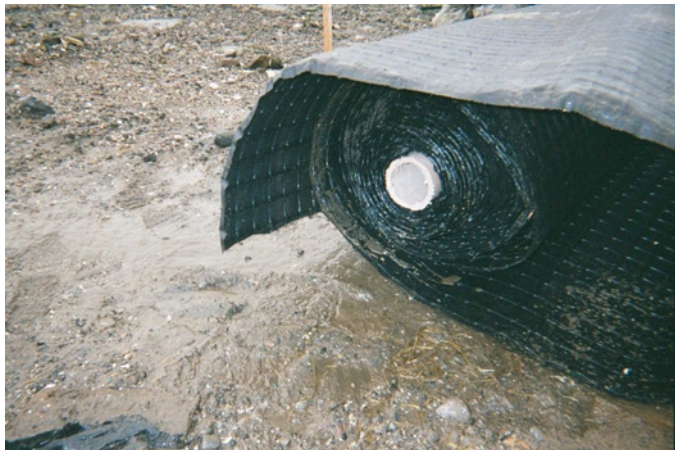
7. Reinforced geogrid utilized under riverine sediment/causeway fill interface details to provide support for marine mattresses.

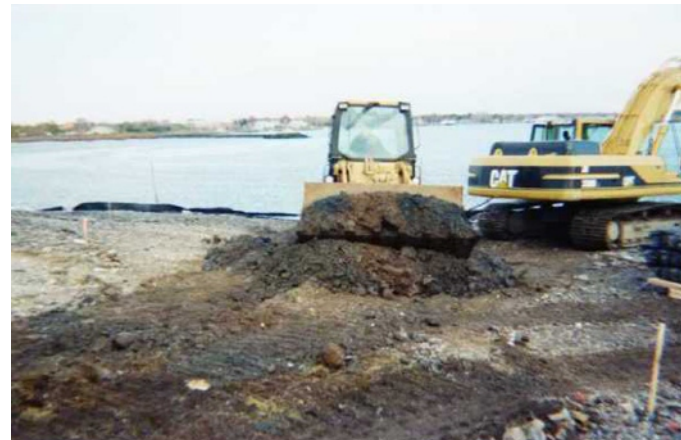
8. Relocating subgrade spoil excavation from lower cover system for scarification and drying.

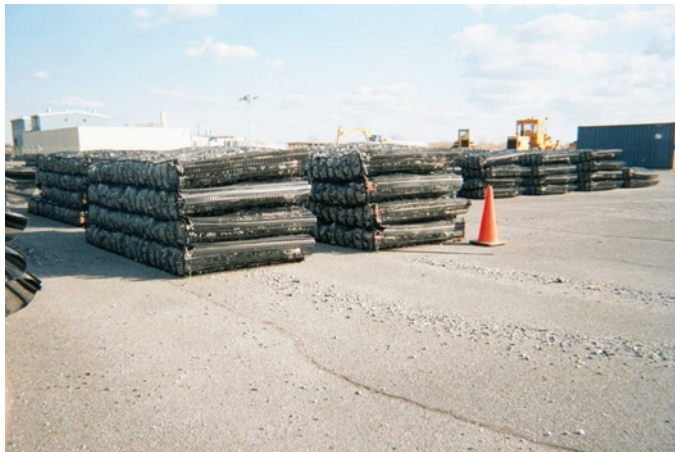
9. Marine mattresses staged in South Parking Lot after fabrication. Note QC flagging on individual units.

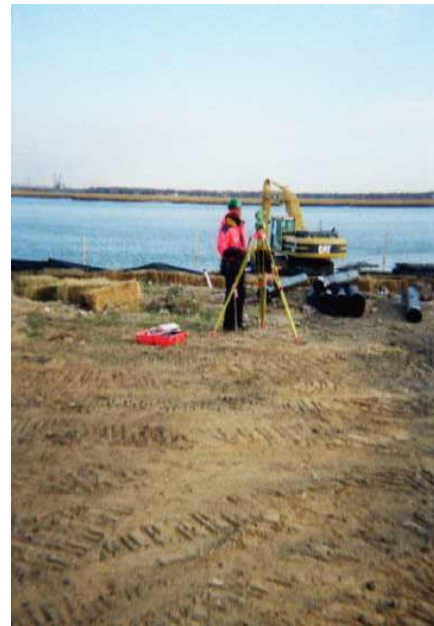
10. Survey of causeway and intertidal settlement/heave monitoring platforms.

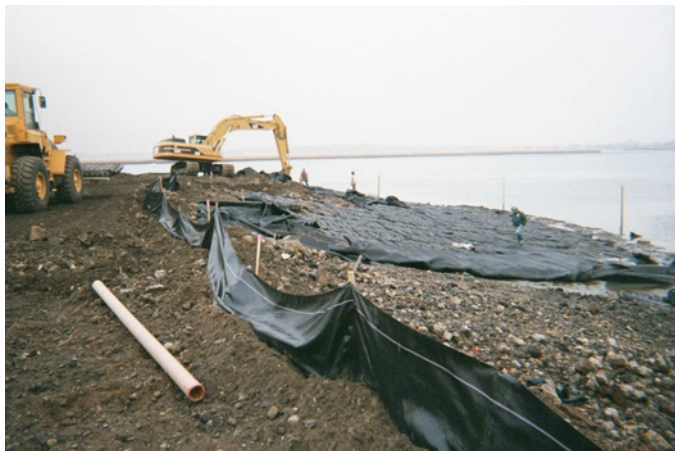
11. Deployment of lower cover system marine mattresses over woven geotextile. Elevation 6.0 MSL is at silt fence line.

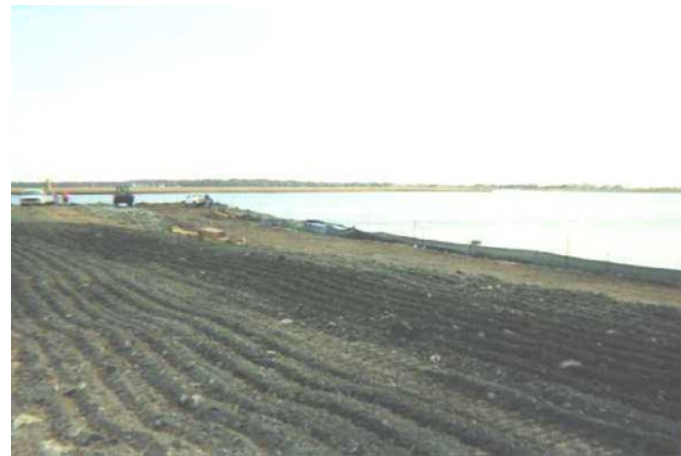
12. Scarification and grading of lower cover system "acceptable" fill material on upper cover area to achieve subgrade contouring.

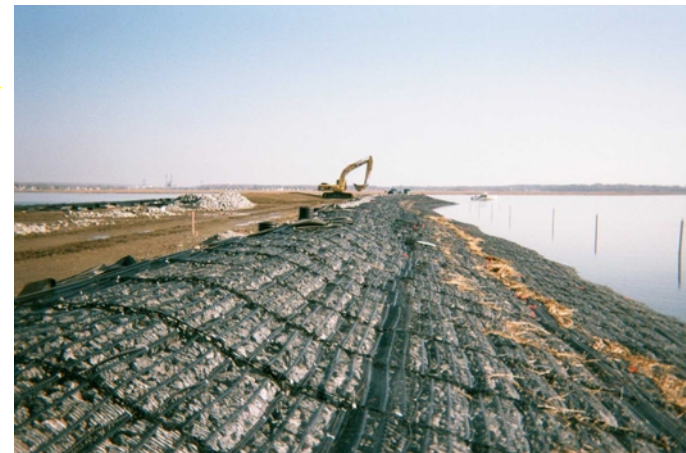
16. Completed area of marine mattress on east side of causeway. Note red flagging indicating QA inspection identified deficiencies.

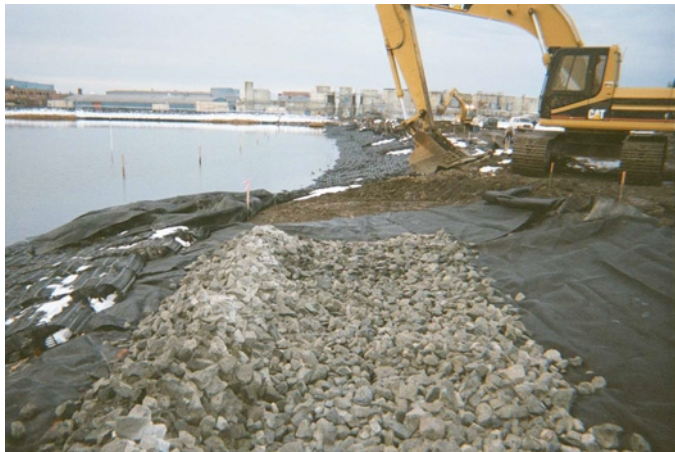
17. Rock filled transition between upper and lower cover systems.

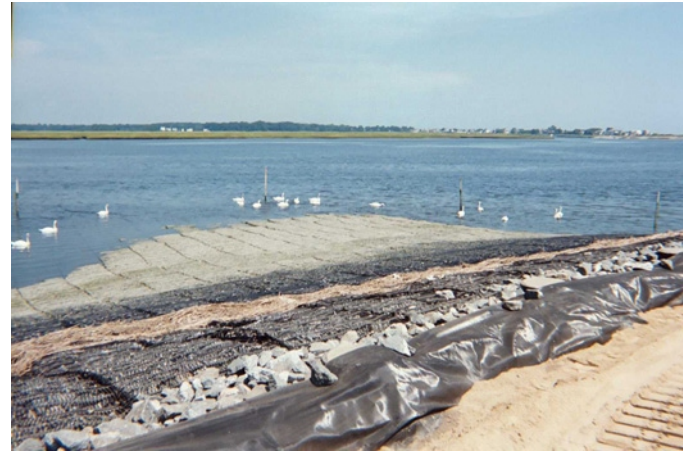
18. View of deployed marine mattresses to the north and east on the Causeway tip. Note Sea grass windrow and algae accumulation on mattresses.

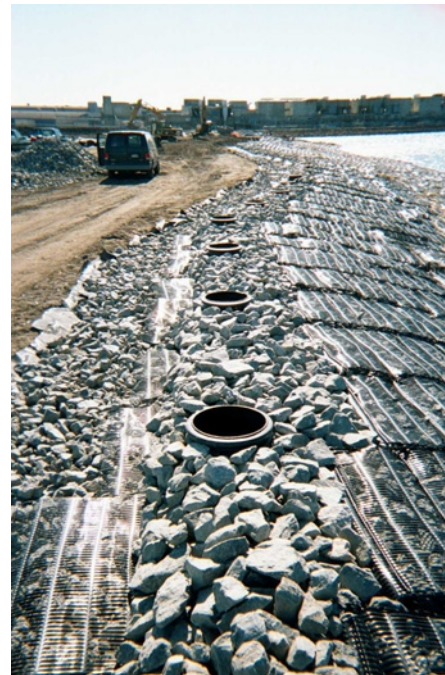
20. Completed rip rap transition with installed fence post bases as a component of Town of Stratford surface design. Note geogrid tab restraints under rip rap.

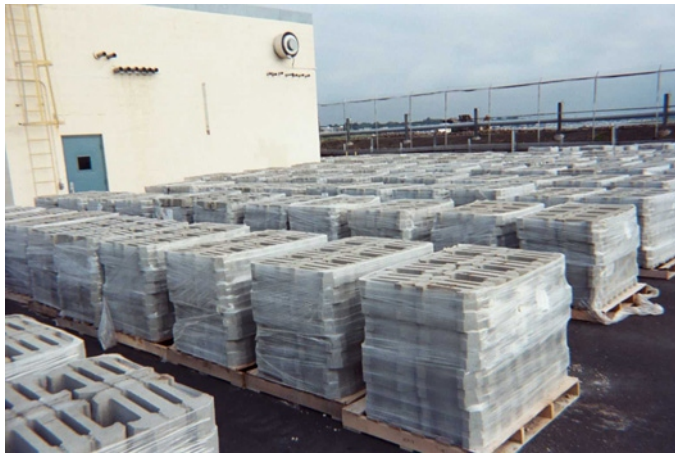
21. Pallets of articulating concrete block staged near Building No. 4 inside south guard post.

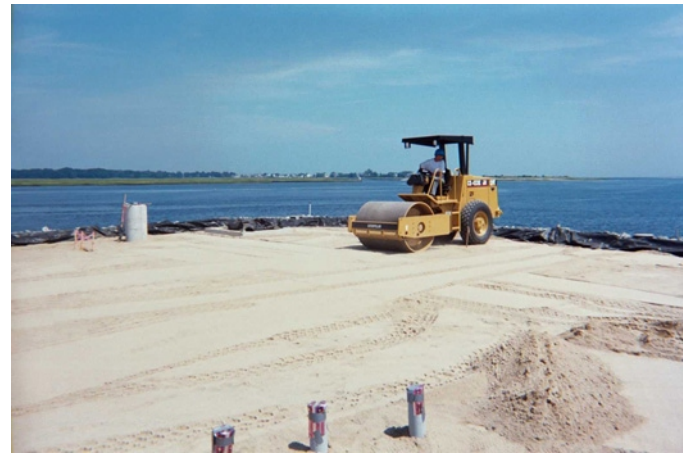
22. Application of bedding sand and compaction prior to articulating concrete block deployment.

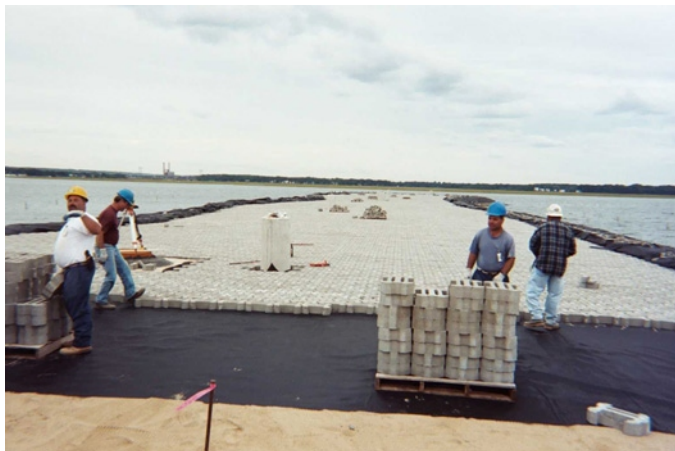
23. Deployment of articulating concrete block over woven geotextile, all deployment was performed by hand. Note concrete light pole base in immediate background.

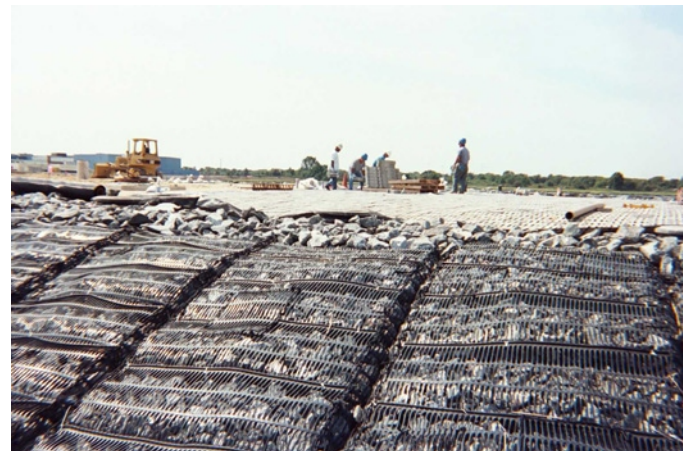
24. Transition from marine mattress to rip rap apron to upper cover system looking to the south west at approximate baseline station 5+50.

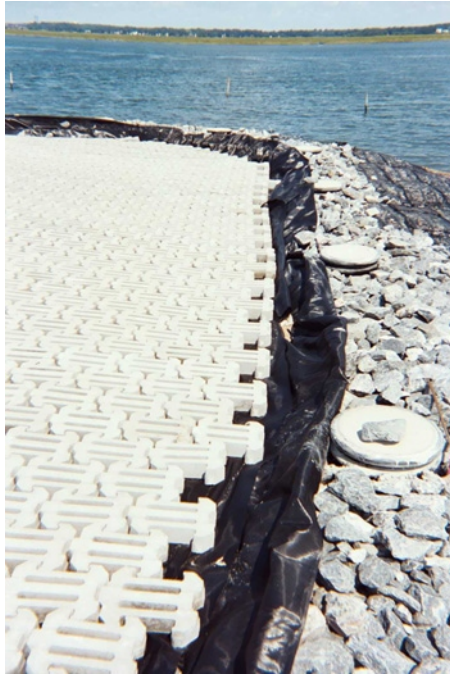
25. Rip-rap transition interface with articulating concrete block.

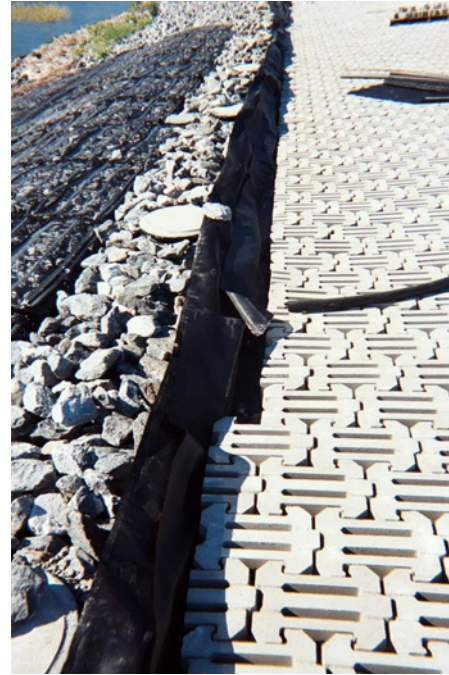
26. Final detailing of articulating concrete block along rip rap apron. Geotextile layer intended to retain vegetative soil from migration into rip rap stone.

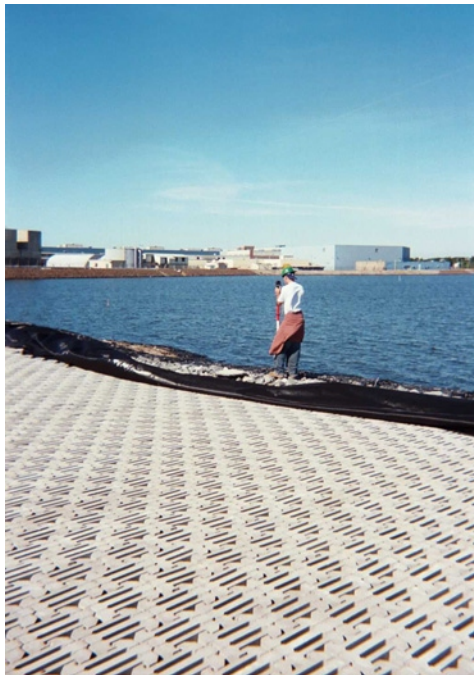
27. Survey documentation of Causeway cover system component limits.

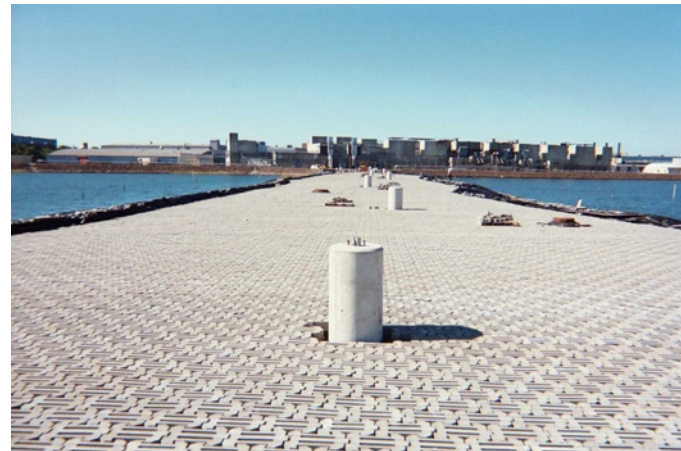
28. Completed articulating concrete block deployment prior to placement of interstitial gravel fill, (photo courtesy of R. F. Weston).

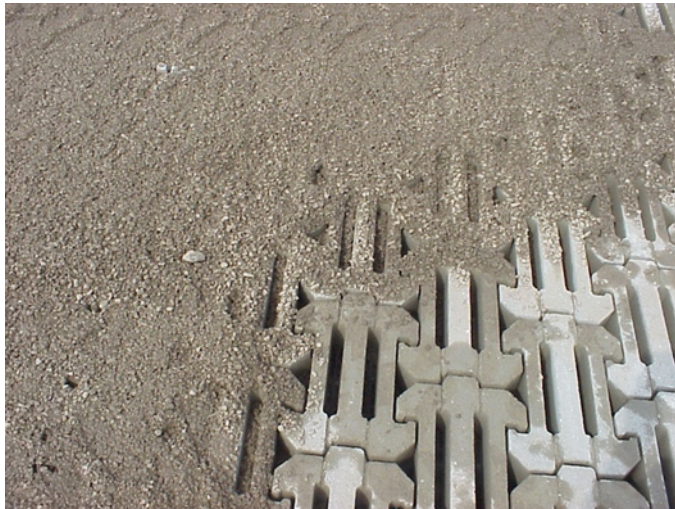
29. Filling of articulating concrete block with interstitial gravel fill (photo courtesy of R. F. Weston).

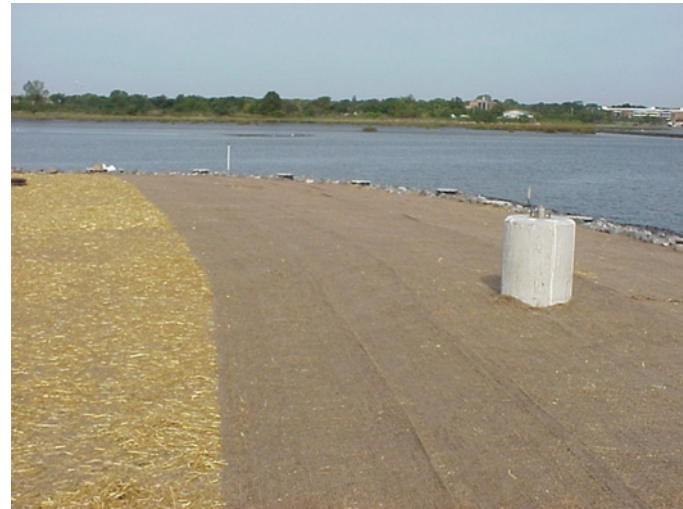
30. Looking north along Causeway with final grading, jute mat application and straw mulch, (photo courtesy of R. F. Weston).

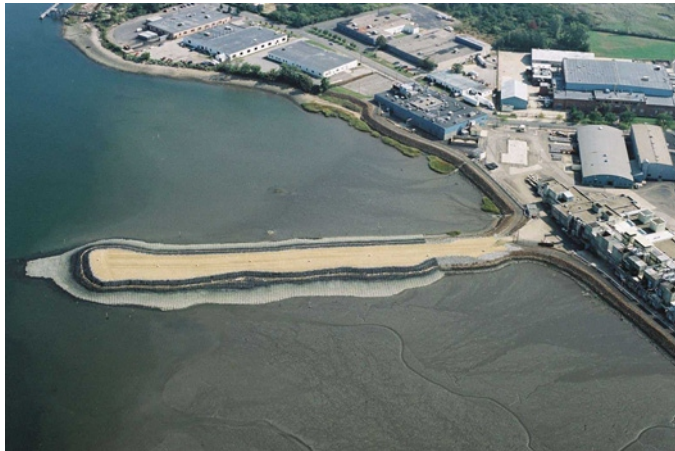
31. Full aerial view of Causeway at completion of sand application, (photo courtesy of R. F. Weston).

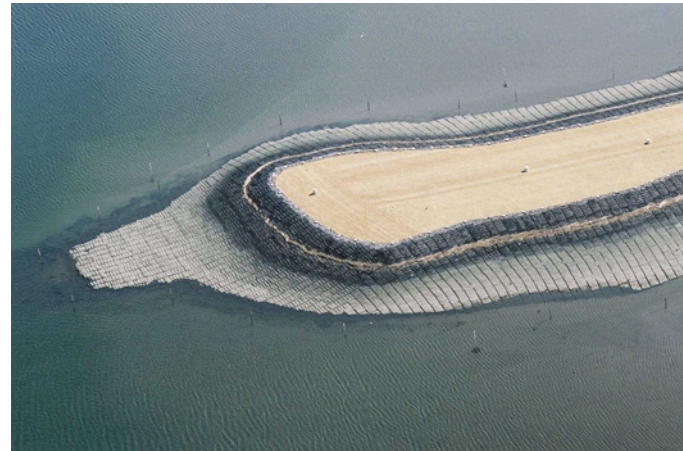
32. Aerial view of Causeway tip post bedding sand application. Note grayish color of marine mattresses indicating algae growth, (photo courtesy of R. F. Weston).

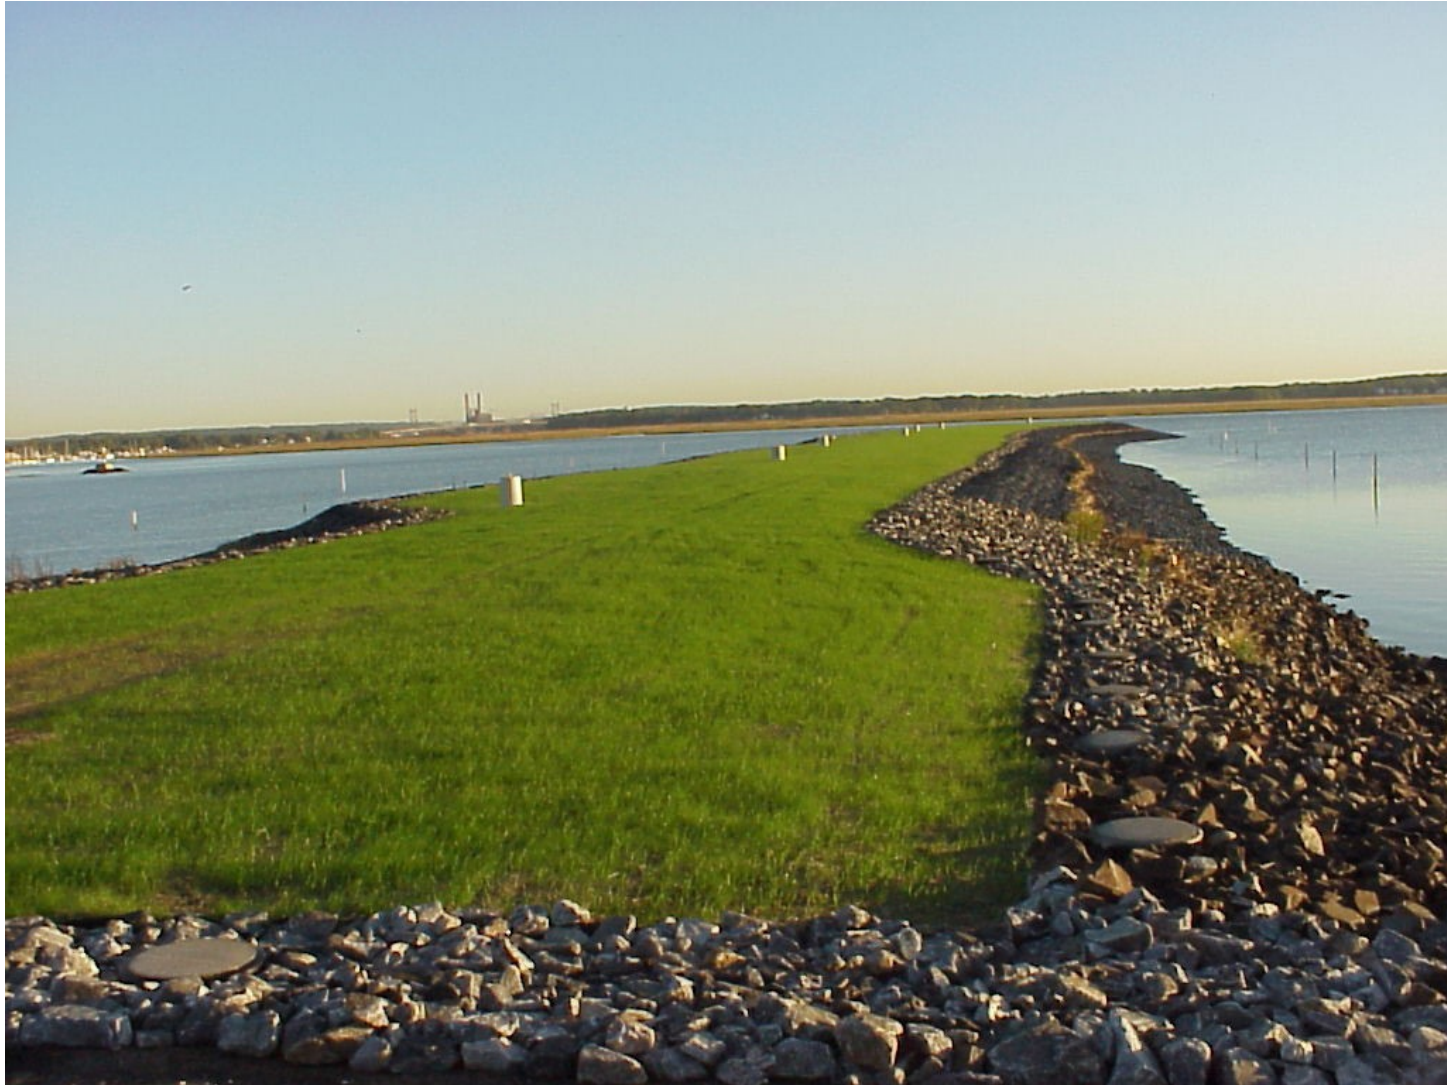
33. View of Causeway with established vegetative cover post-construction (Oct 2002), (photo courtesy of R. F. Weston).
